Building Survey

The Old Vicarage

Report produced by Peter Ward, BSc

July 2021

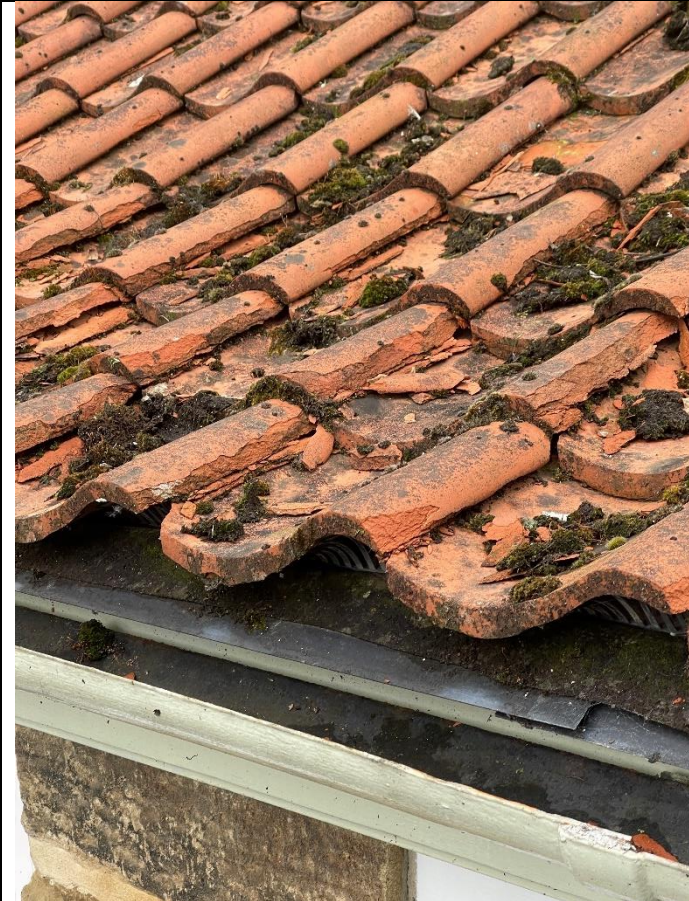
The pantile roof to the rear catslide extension is very badly damaged by weathering. It is also heavily moss infested, which may have contributed to the spalling that is evident. I understand this was 'aged' using yoghurt when first re-roofed, and this has unfortunately accelerated decline. This all needs to be urgently replaced.

Badly deteriorated
pantiles require
replacement.

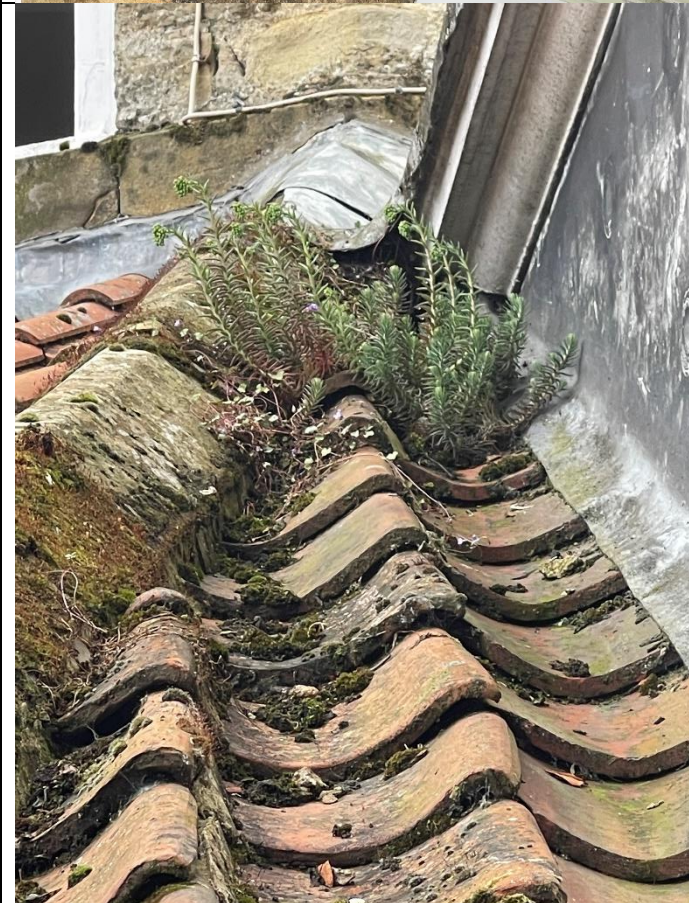
Poor maintenance
resulting in frost
damage, water
ingress etc.

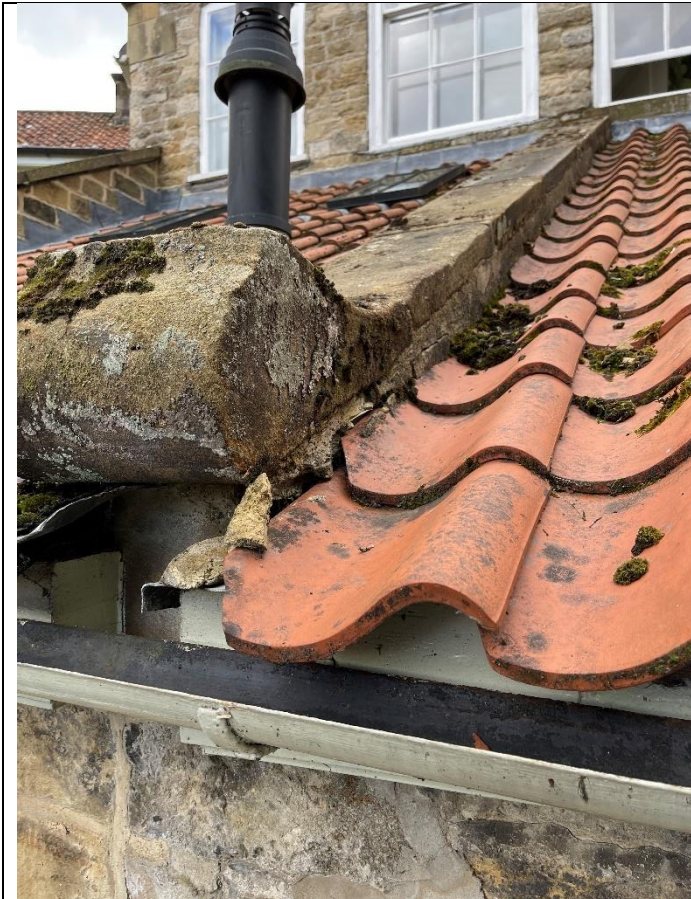
Water able to track underneath the kneeler and soak the walls.

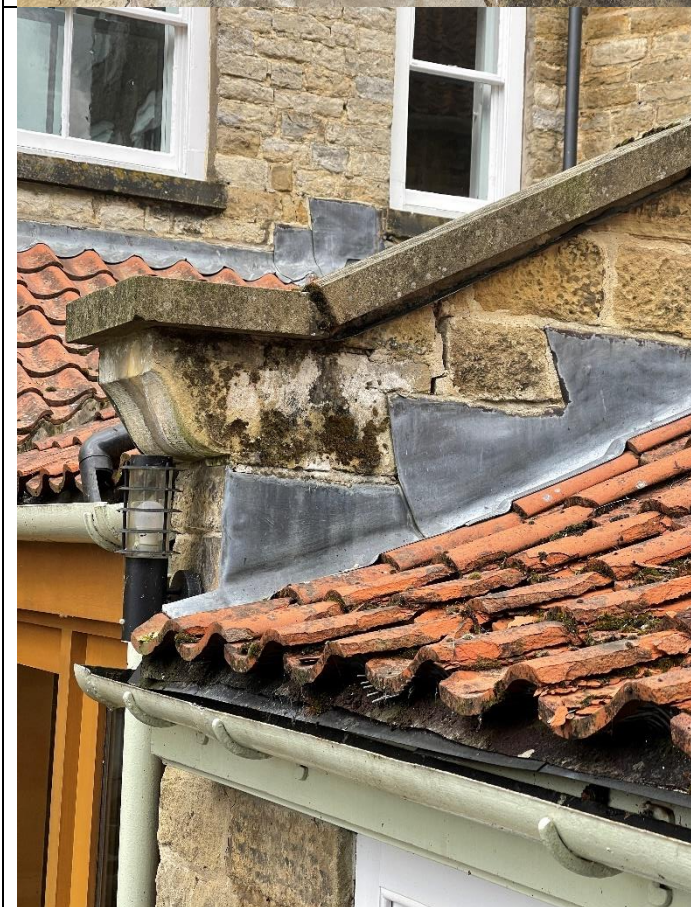
Disintegrating parapet built with cement, water tracking from coping to kneeler and soaking top of wall. Note disintegrating pantiles.

Note wet wall around downpipe in background.

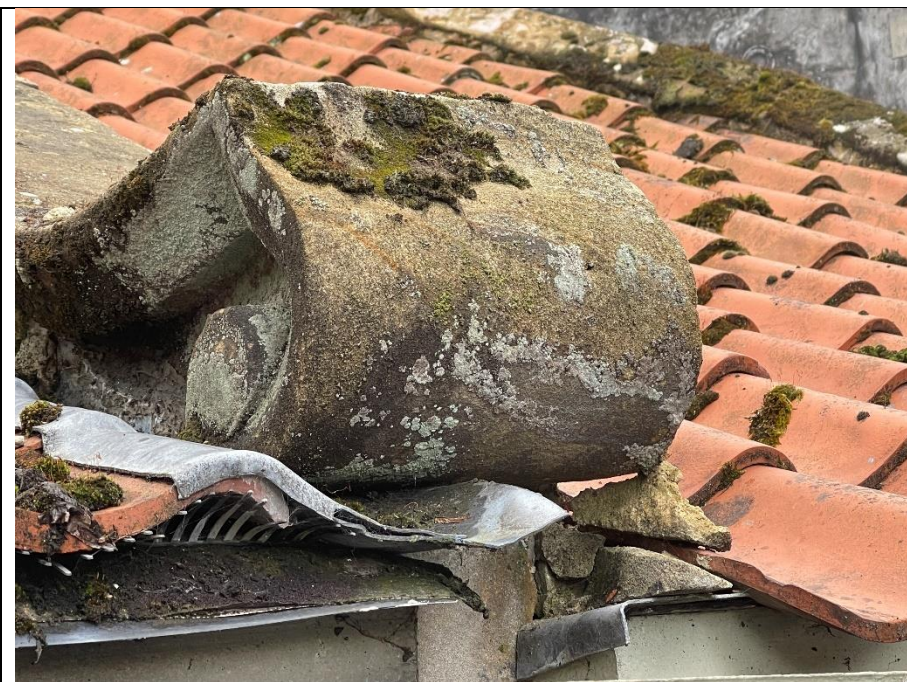
Parapet wall, disintegrating kneeler with similar problem – laid in cement, water tracking down back of kneeler and into wall. Note crumbling cement below it. Leadwork fitted incorrectly, ponding water in the middle of the stonework underneath it. There is even evidence of resin being used to try and seal cracks.

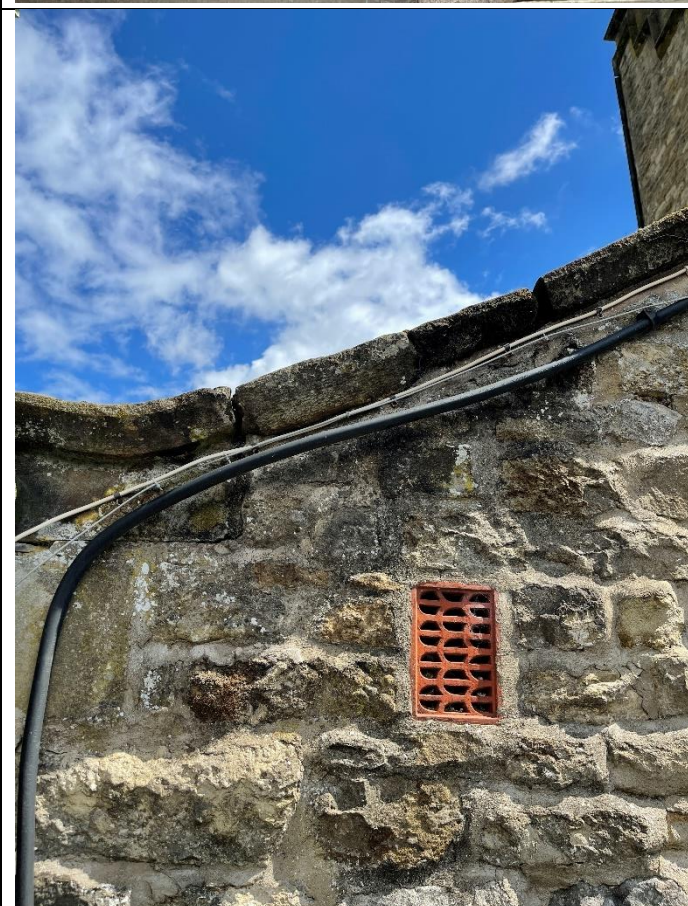
Main building – parapet capstones fitted with cement, water ponding into top of wall behind kneeler and causing surface damage to pointing and stonework. Note cement pointing. One wonders whether a more sensitive approach could be taken to cable location if restoration work takes place.

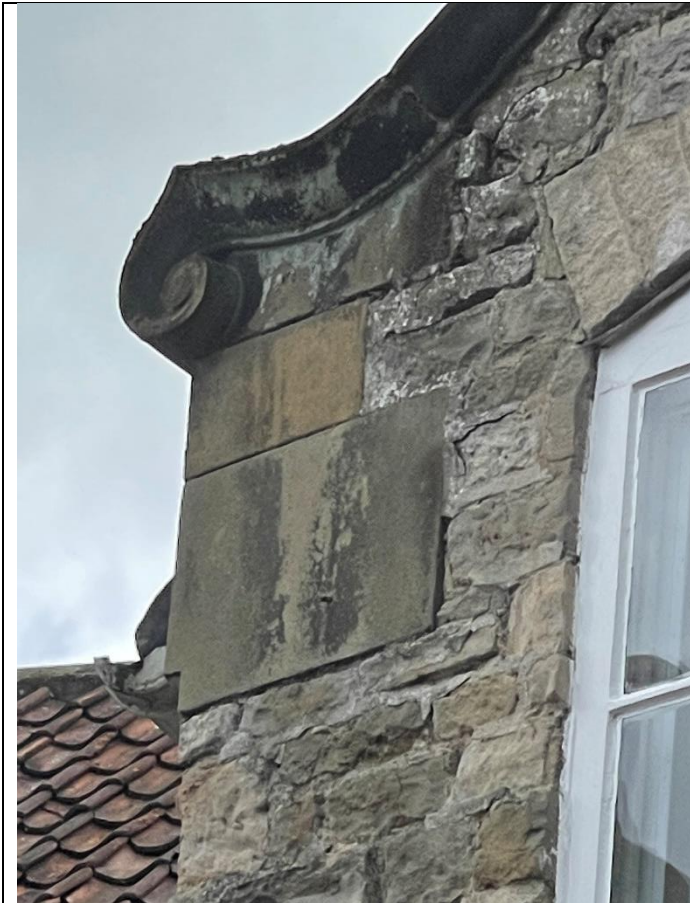
Water has been pouring off kneeler and running down wall, damaging stone below. Cement pointing is falling out of joints, indicating severe moisture stress. All of this needs to be removed, and the parapet caps re-set and profiled to direct water correctly. Windows leak around frames, excessive use of plastic paints is helping to rot them.

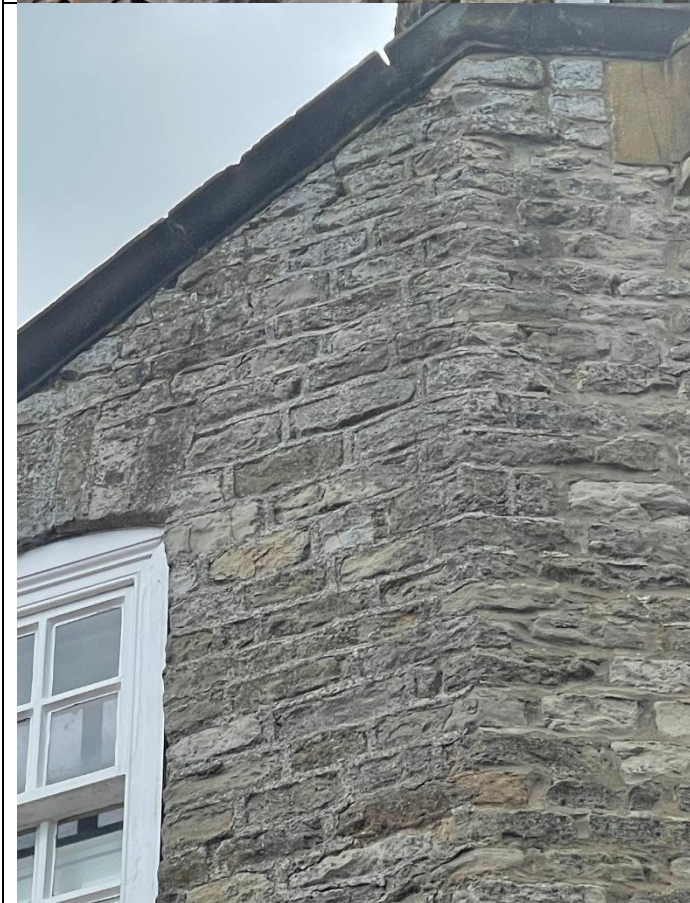
Gaps to the capstones, allowing water to run into the top of the wall. All set in cement, which has cracked and is trapping moisture into the wall. Most of the wall re-pointed in cement. Needs removal and replacing with hot lime mortar. Note partial disintegration of some of the stones. This will just become progressively worse if cement is left in place.

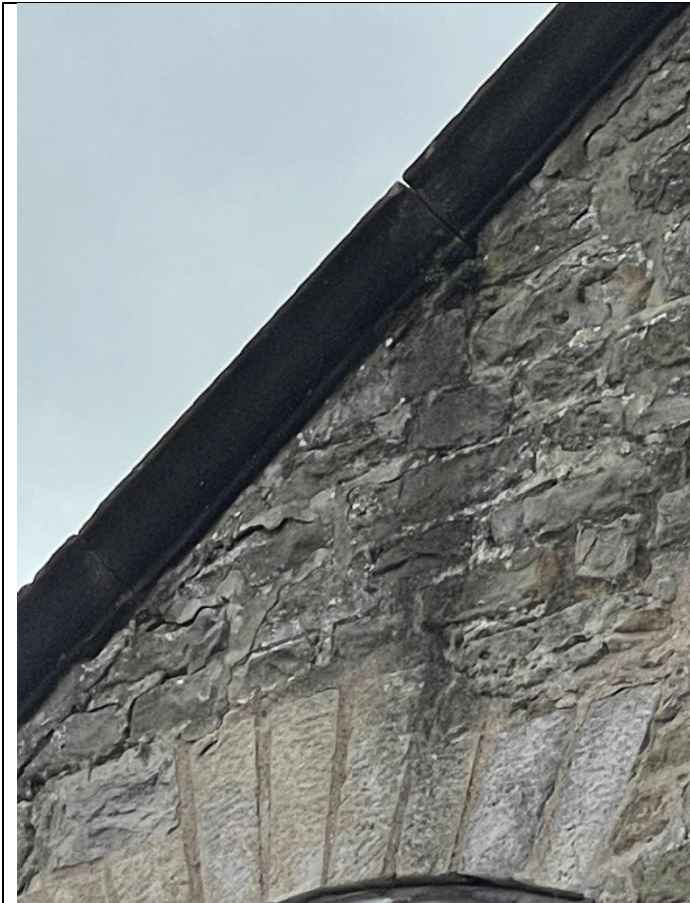
Water tracking down wall from cracks and gaps in the copings.

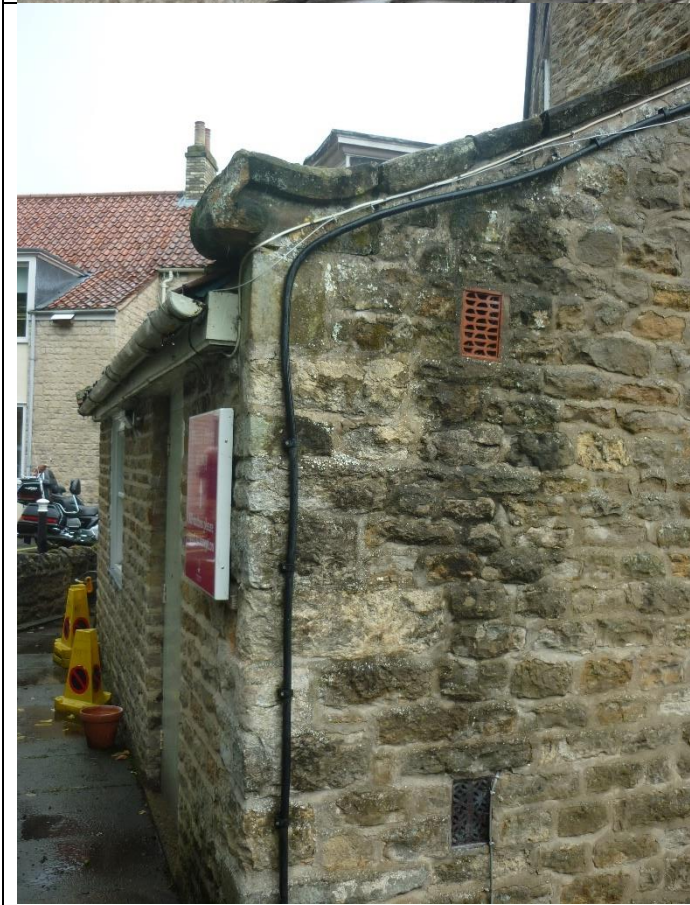
Side elevation – water being shed from parapet copings, and soaking wall causing damp problems internally. Note rather insensitive placement of cables within the Listed setting.

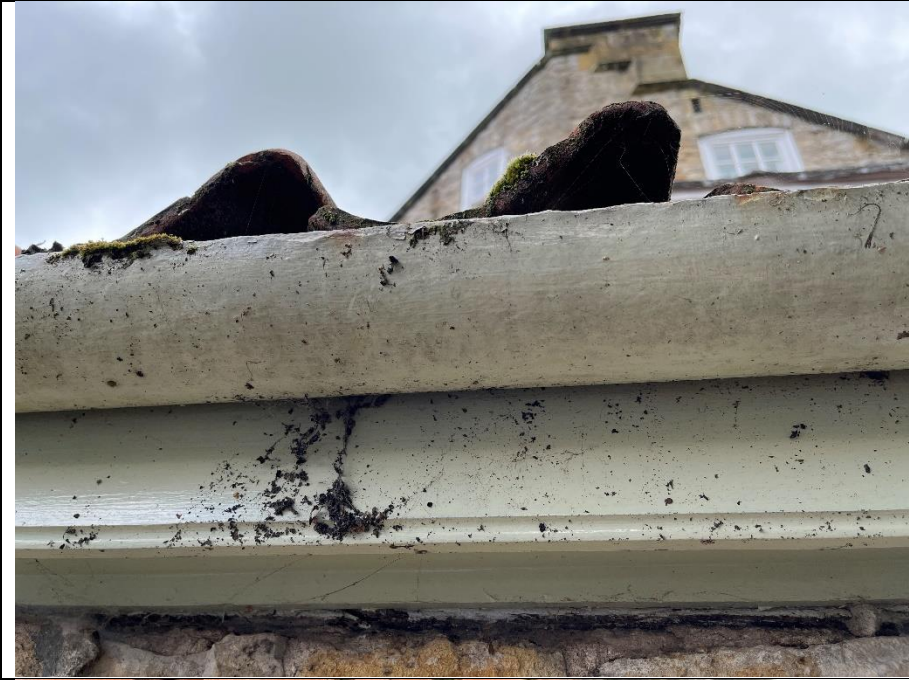
Poorly maintained gutters tipping backwards, soaking fascias, and allowing water ingress internally.

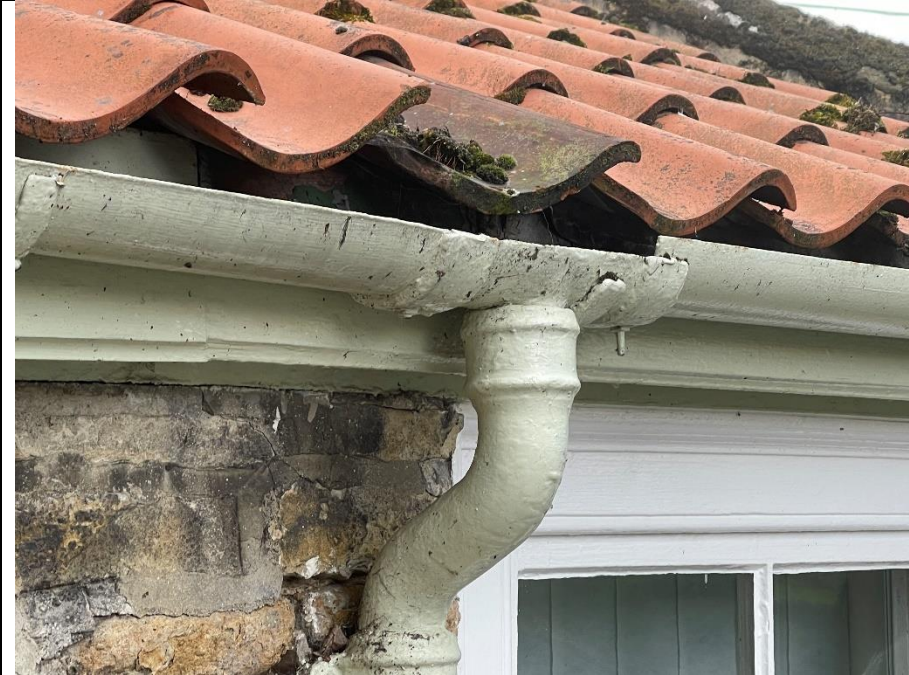
Complete break in gutter – not properly sealed and dripping water down the wall and onto ground where it splashes the base of walls and creates damp problems. Note deteriorating stonework where it is being constantly wetted.

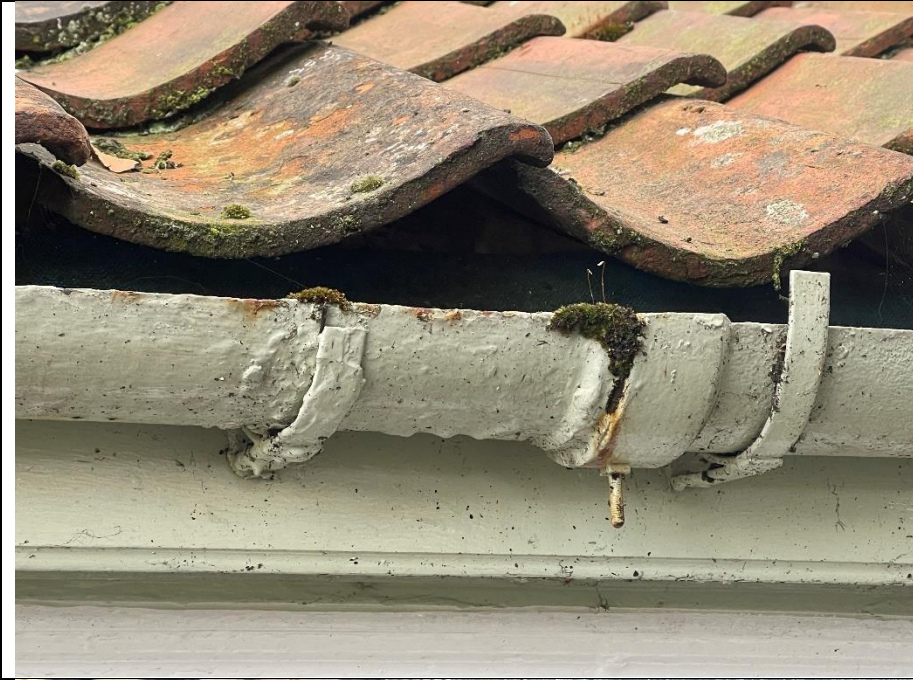
Similar problem – old join, rusted, and leaking.

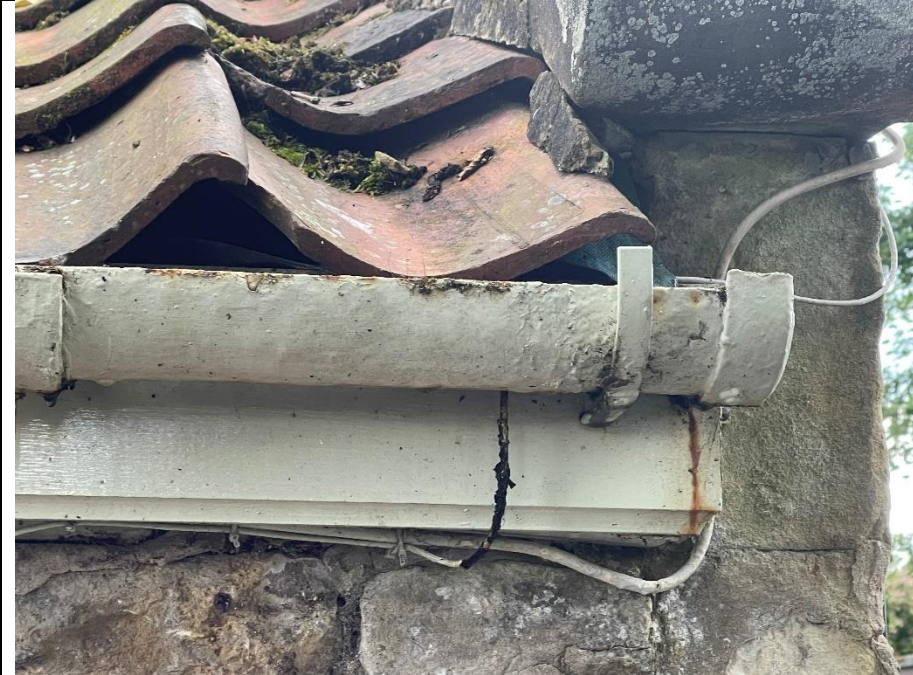
Gutter in this case wrongly angled and allowing water to both run out of the end and down the wall. Note rust staining on the fascia and spalling stone.

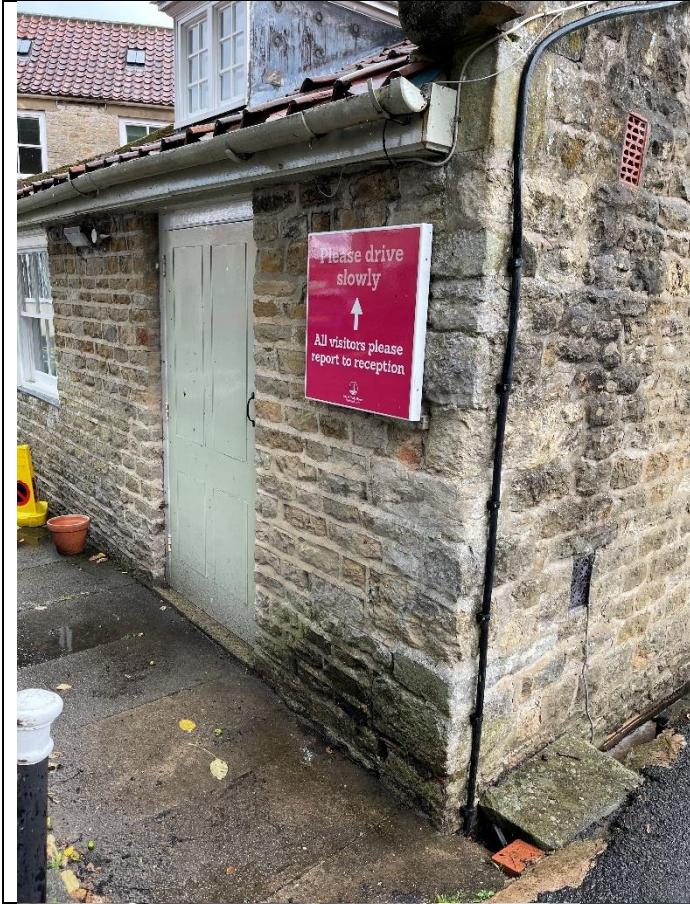
Gutter in photo above, showing how the base of the wall is soaked, and suffering damp internally. Water running under door, and splashing / rotting door frame as well as the fascia board that is soaked every time it rains. Very poor maintenance. Ground levels are at least 150mm too high.

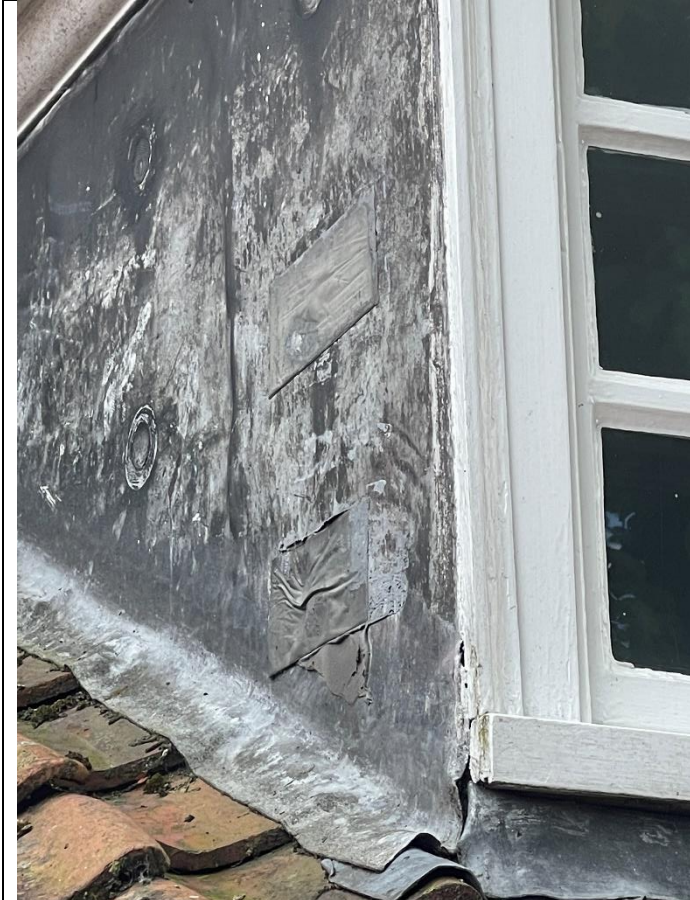
Lead cheeks to dormer are scrap and need total replacement. Serious leakage internally to this room.

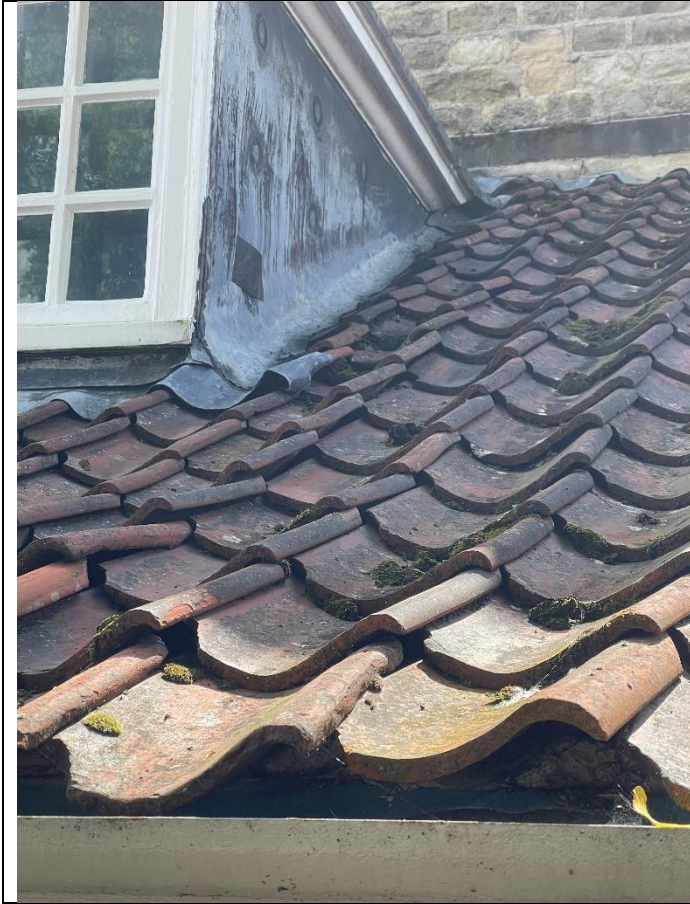
This entire roof section is scrap and is allowing water ingress. I am surprised it has not collapsed into the roof space below.

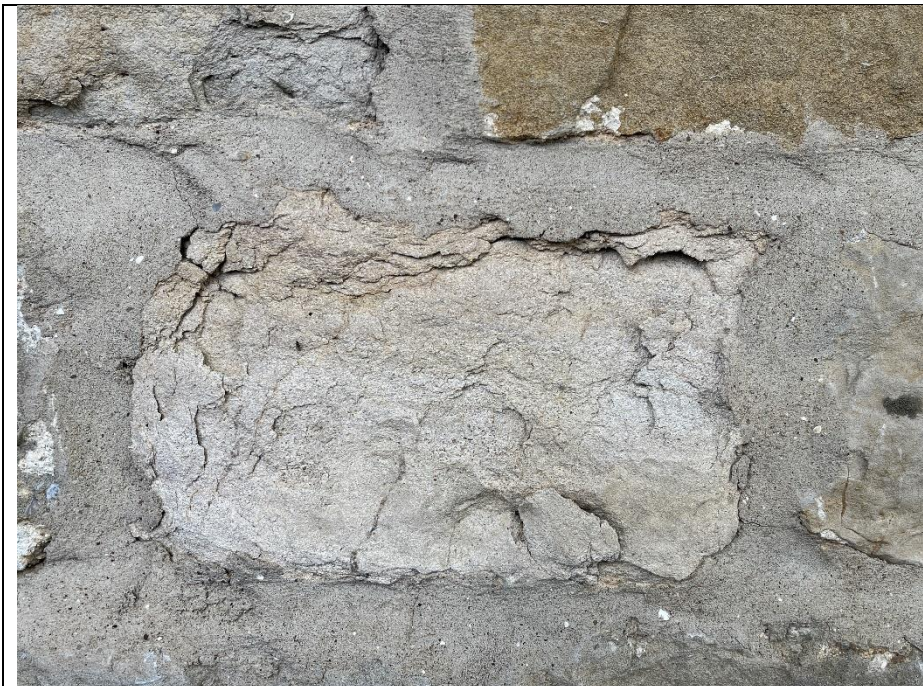
Cement pointing, causing spalling of the sandstone.

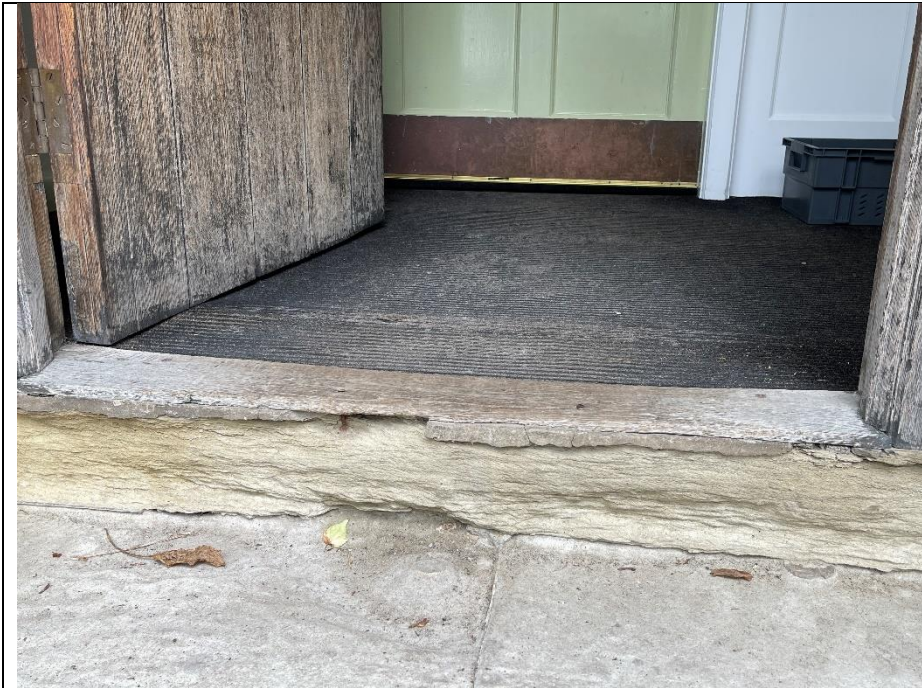
Spalled stone step. Partly caused by the waterproof coatings over the top of the slab in the entrance foyer. This is trapping moisture, which is breaking away through the edge of the slab preferentially. Perhaps the original stone surface can be exposed to allow it to remain dry..

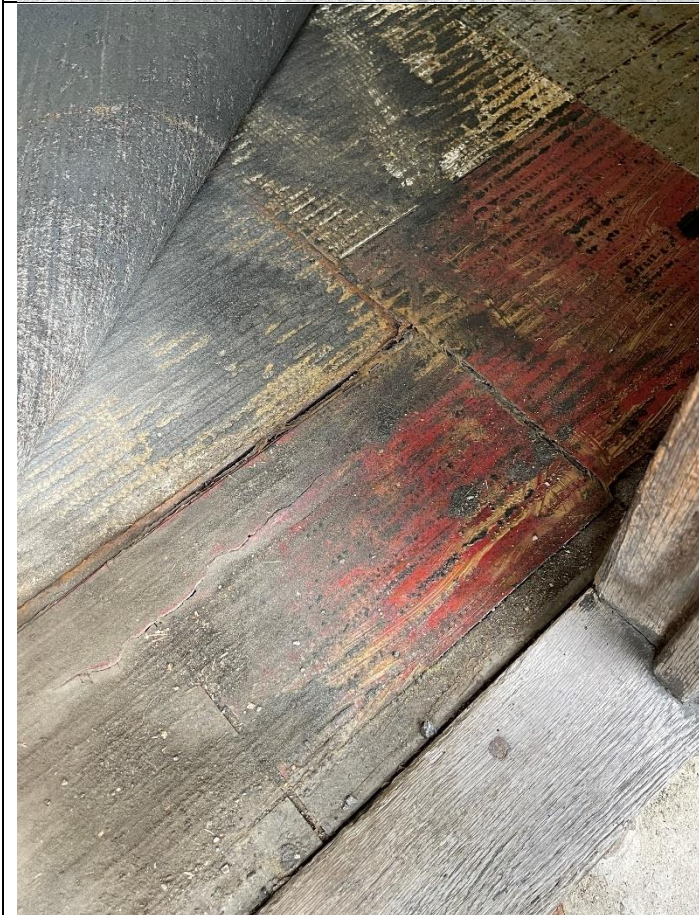
Impervious coatings damaging stone slabs in foyer – ideally this needs to be removed and the stone exposed so it can stay dry.

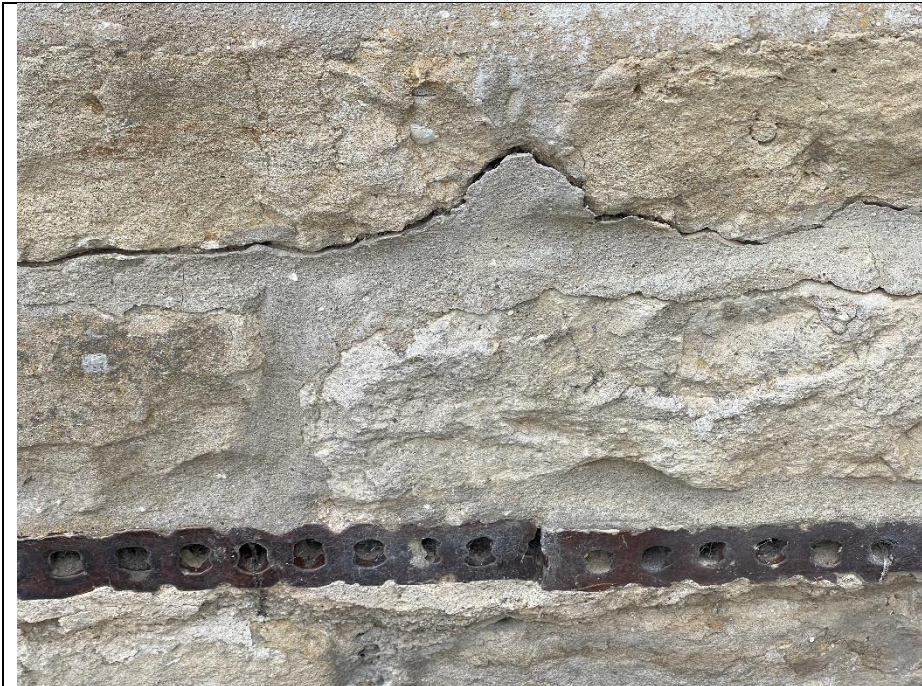
Cement pointing allowing water ingress to stone – there may be minor movement as a result of breakdown in the lime mortar at low level. I suspect water has tracked in through the porous bricks at ground level.

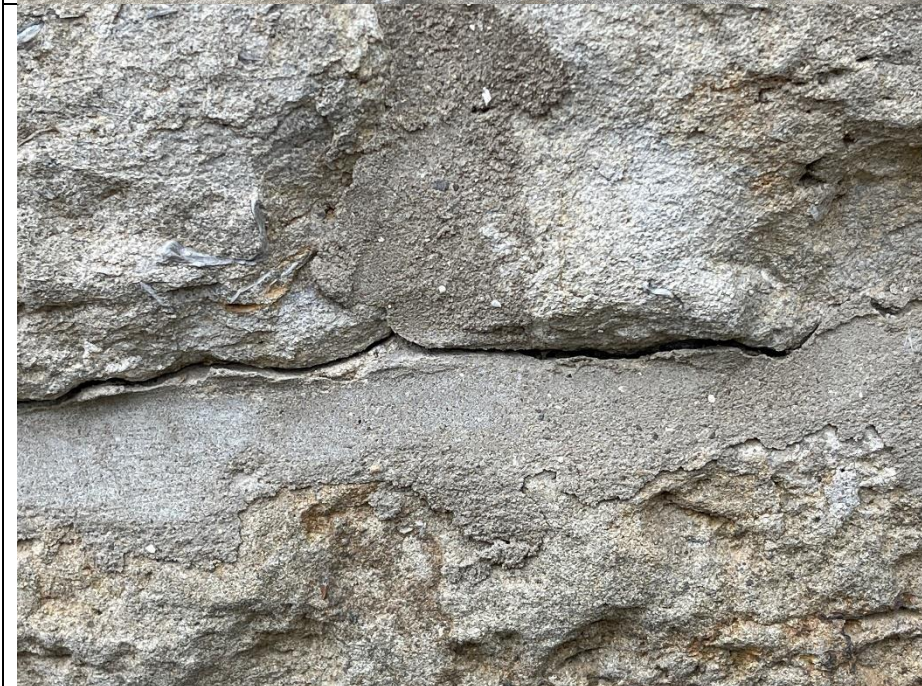
Another cement pointed joint allowing water ingress.

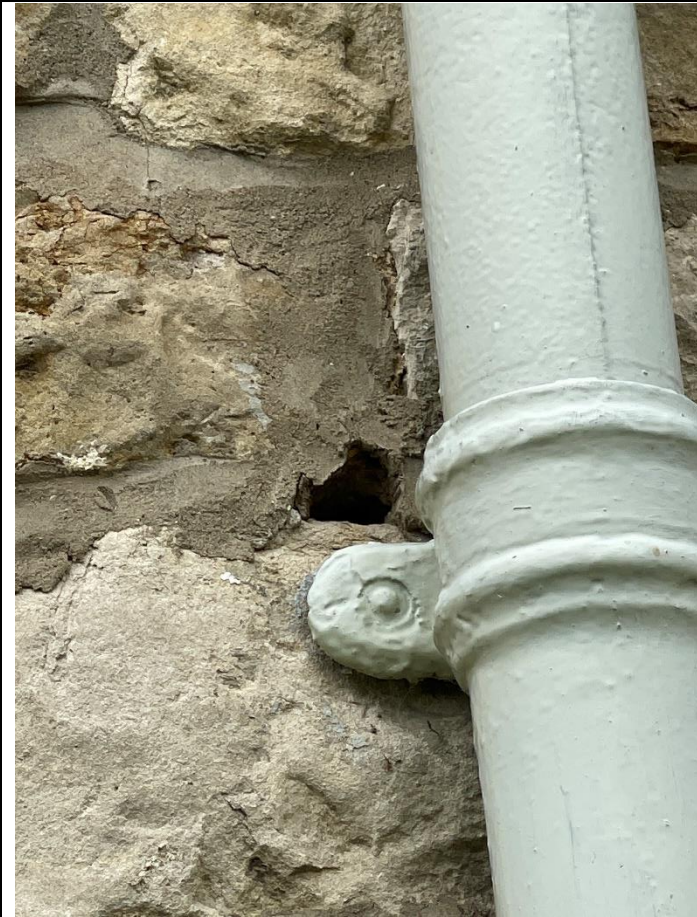
Poor quality cement pointing and exposed hole allowing water ingress.

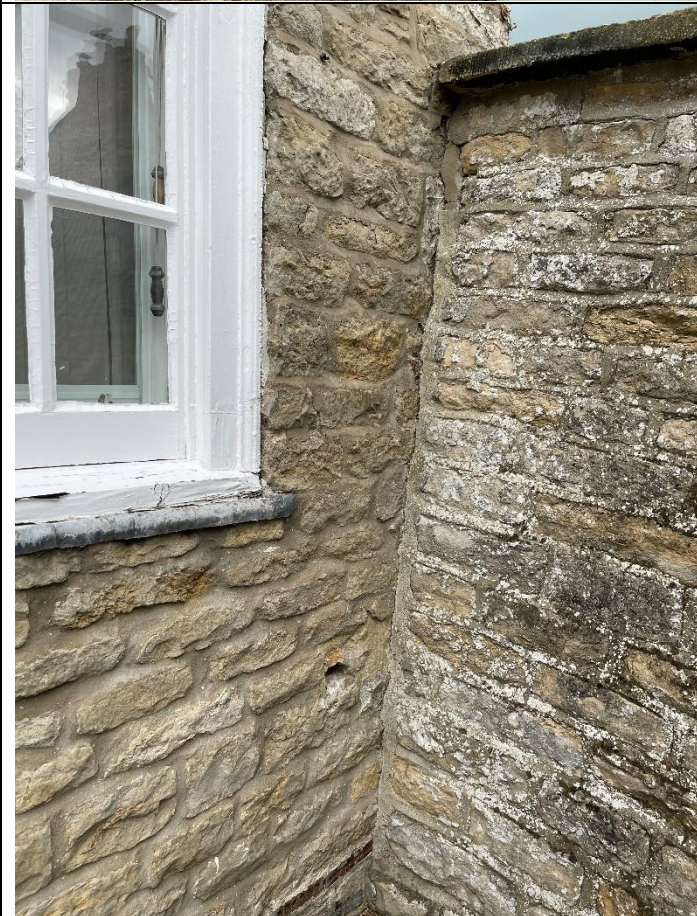
Cement pointed wall butting up to the building. The joint will hold water into the main wall, creating damp problems internally. Note also disintegrating window sill. This joint needs to be raked out and allowed to dry. It can be plugged with hot lime mortar which will let moisture go.

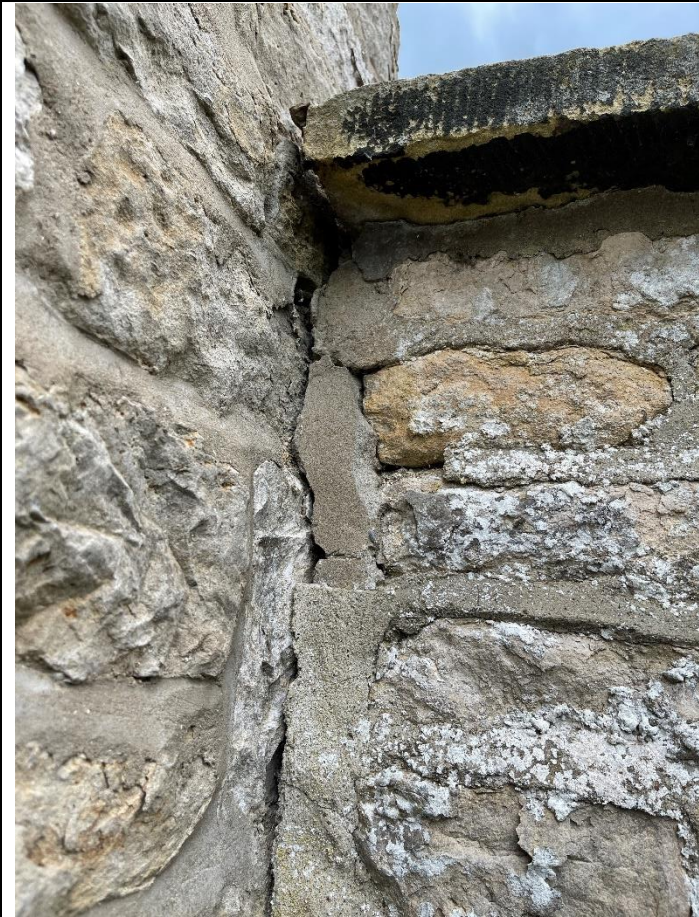
Detail of the top of wall, showing how cement is disintegrating and trapping moisture at the same time. Note spalling stonework on the right.

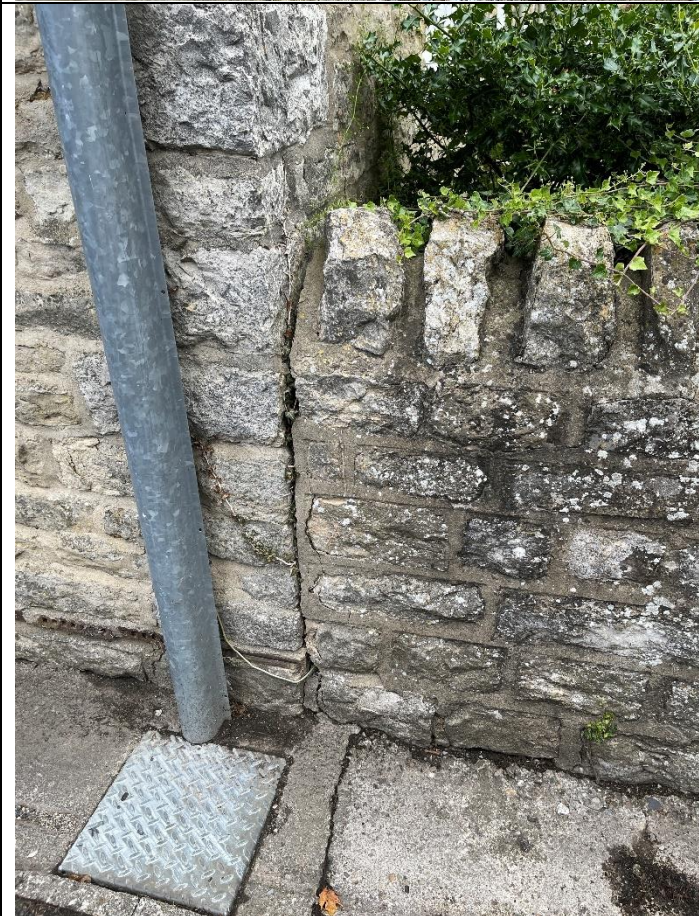
Lower wall, but very similar situation, moisture trapped by cement construction. This should be separated from the main house wall.

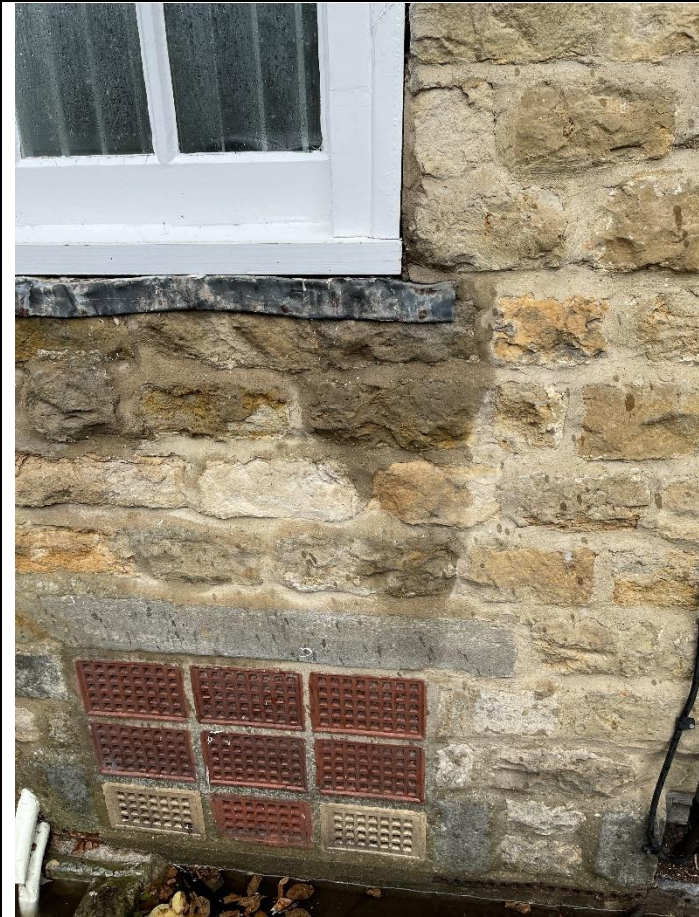
Very poor detailing causing soaking of the stone wall. There is no cill to the window to provide a drip rail. Note gap around window which needs to be plugged with a breathable sealer (oakum) and pointed with hot lime.

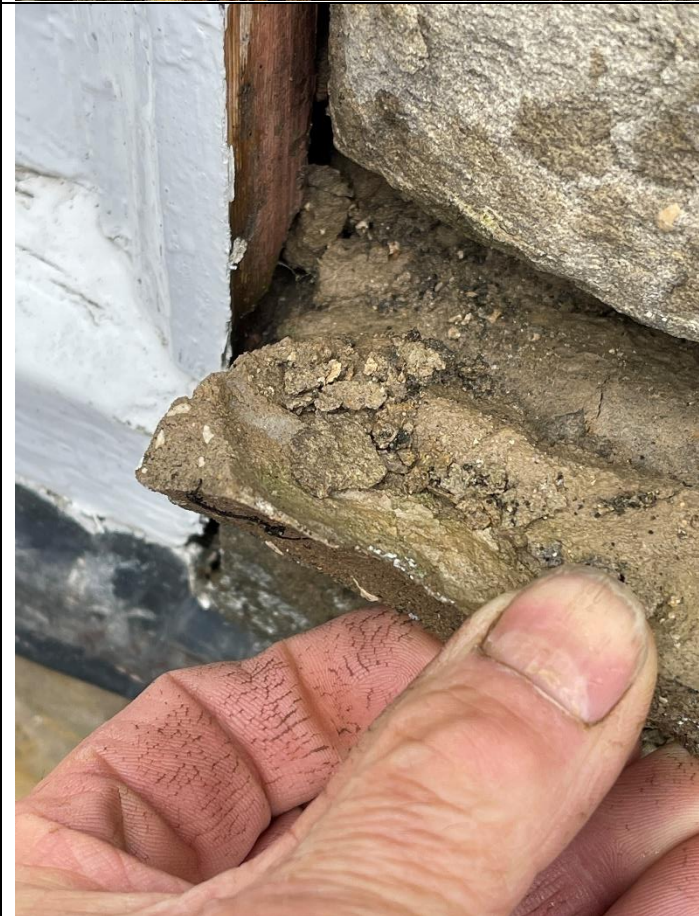
Detail of window above – mortar being forced out of joint by water – wall is sopping wet behind. Frame exposed to the elements and rotting towards the bottom.

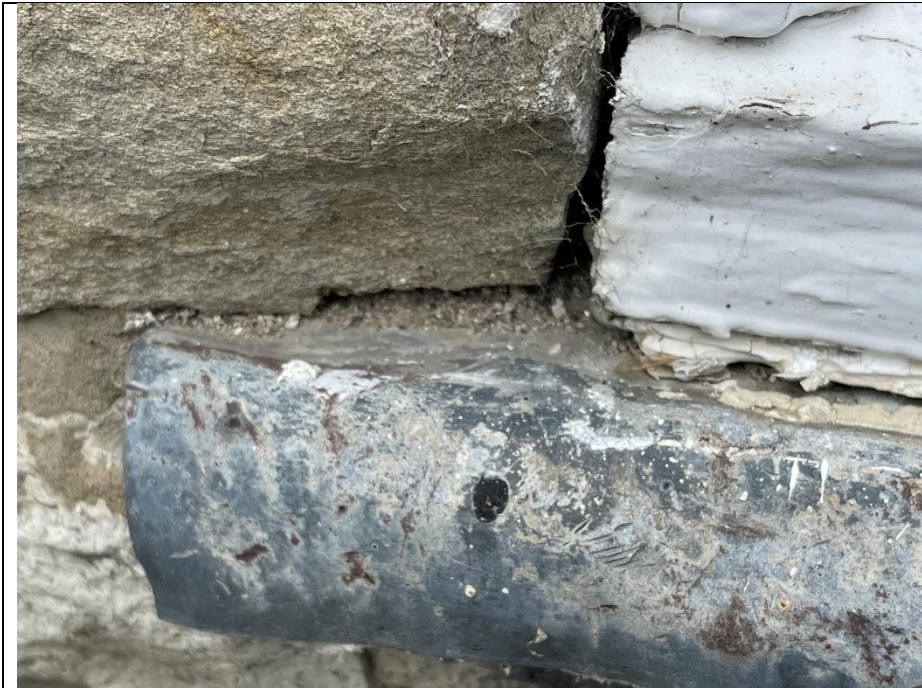
Very poor detailing of base of window – no cill, and gaps allowing water ingress. Plastic paints trapping water into timber and rotting it. Lead flashing is actually tilted backwards and pushing water under the cill.

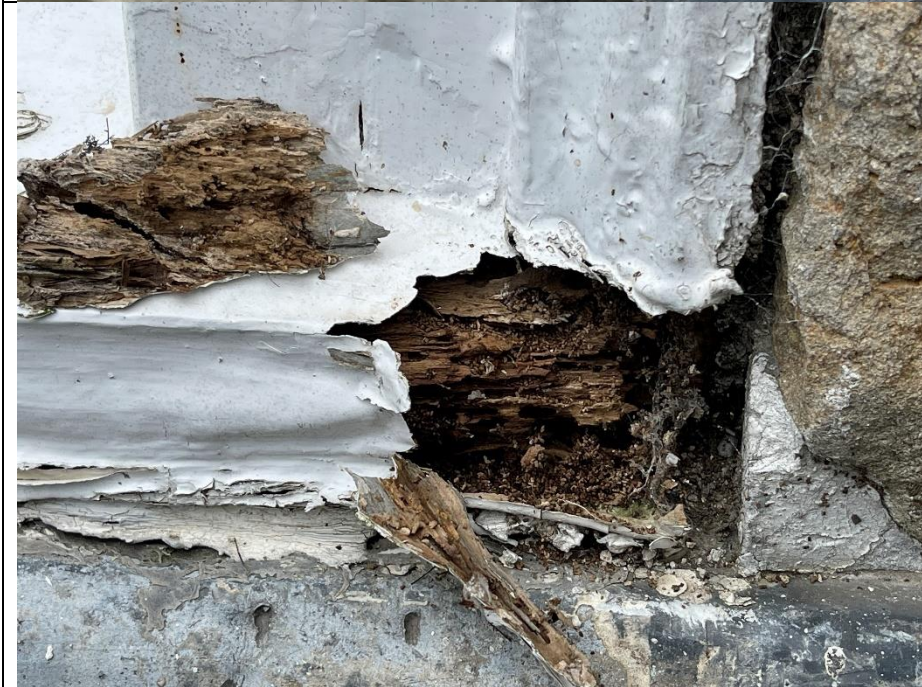
Ditto – water trapped into timber, rotting it. Cement repairs, poorly fitted lead which actually would be better if it was not there at all – as the base of the window sill would at least be in contact with stone, and able to dry out, rather than having water trapped by impermeable lead.

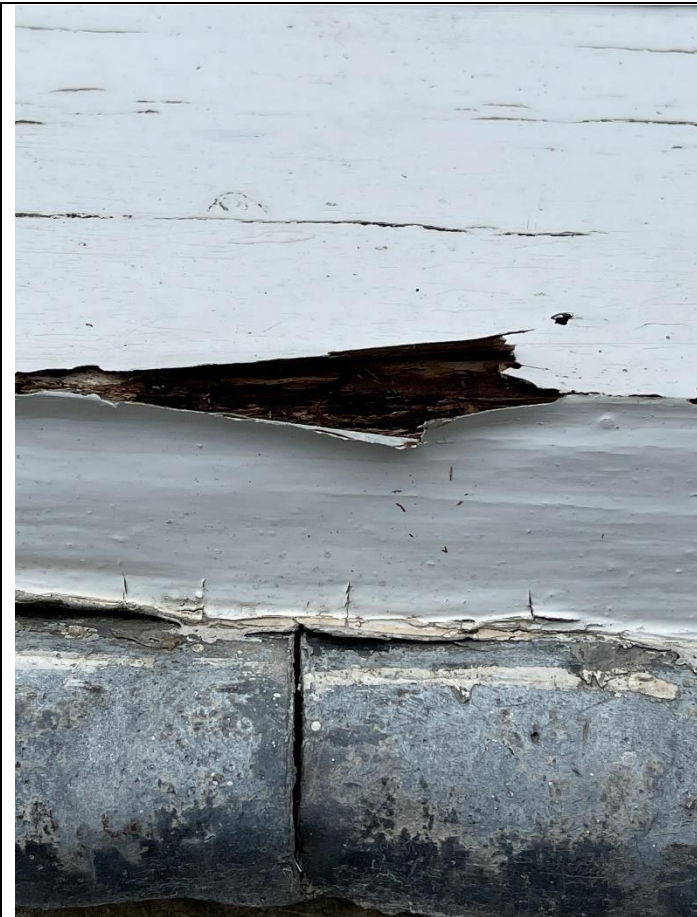
Another rotted cill. All windows need to be stripped of plastic paint and linseed paint system used. (Linseed Paint Company based in Leeds)

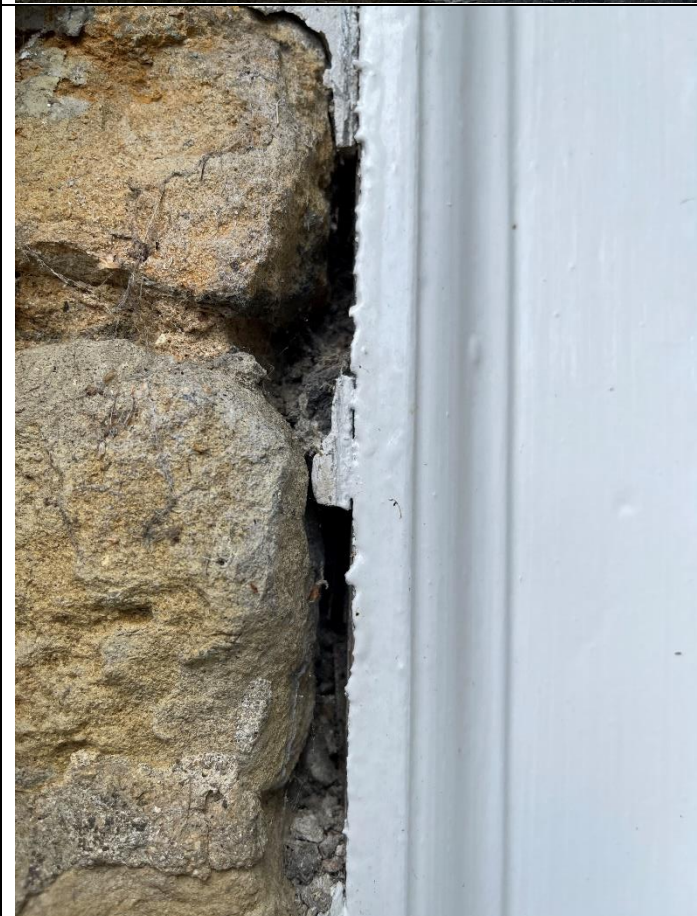
Gaps around windows allow water ingress. Gaps such as this also allow cold air flow in winter, which encourages draughts, and consequential dampness / mould etc. Properly attending to such gaps makes the building more airtight, and helps enormously in reduction of overall energy usage.

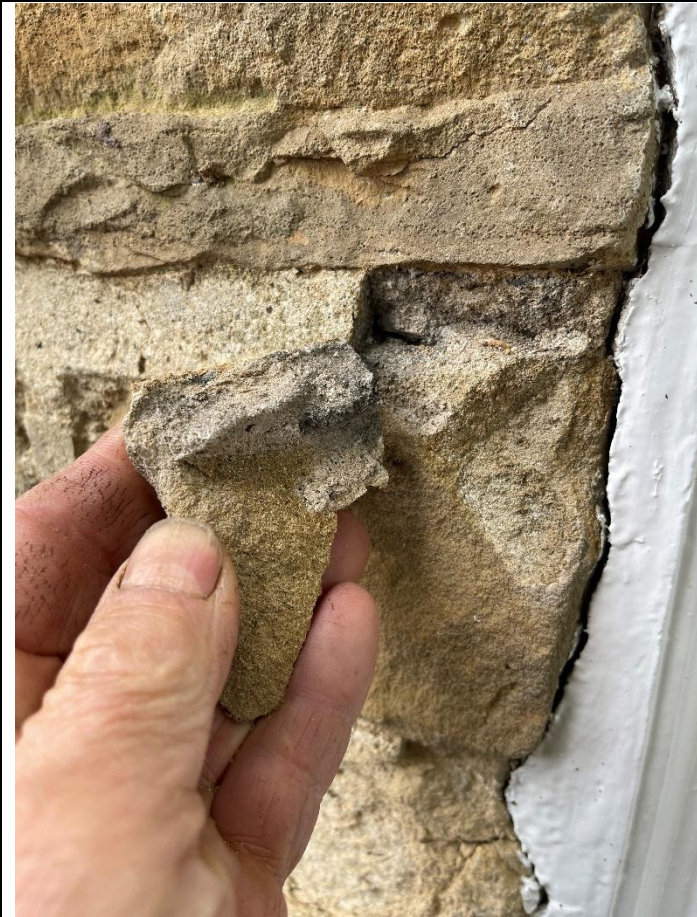
Cement removed to expose lime mortar underneath. Gap round window allowing water ingress and draughts.

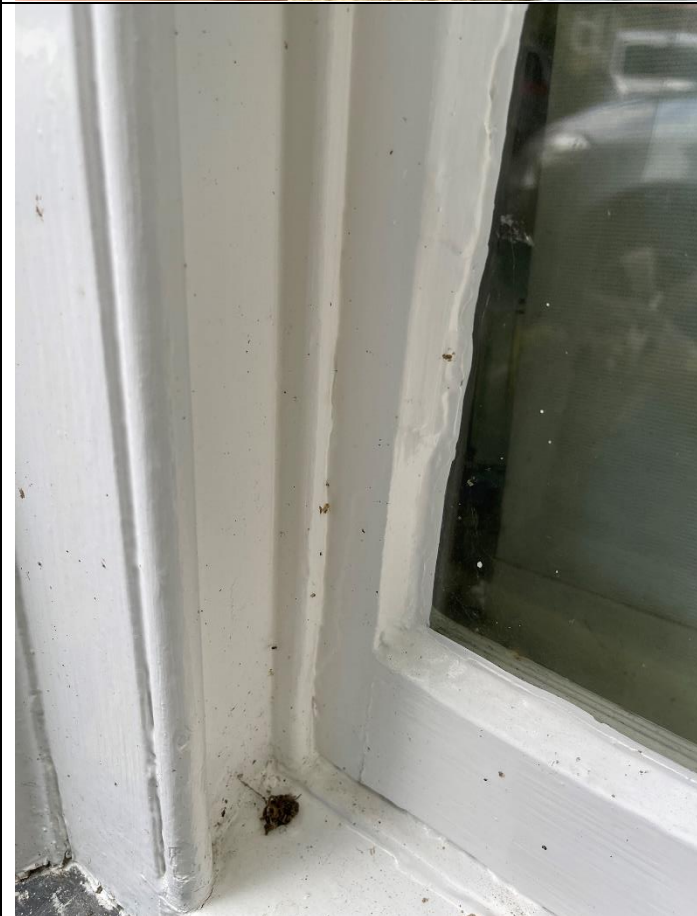
Poorly maintained sash window – multiple layers of paint, sticking entire system together. These can be completely restored, and weather sealing applied to parting rails and beads before painting with linseed paint system. (This system used now by Chatsworth Estate, resulting in over 75% reduction in external joinery maintenance costs)
