Building Survey

The Old Vicarage

Report produced by Peter Ward, BSc

July 2021

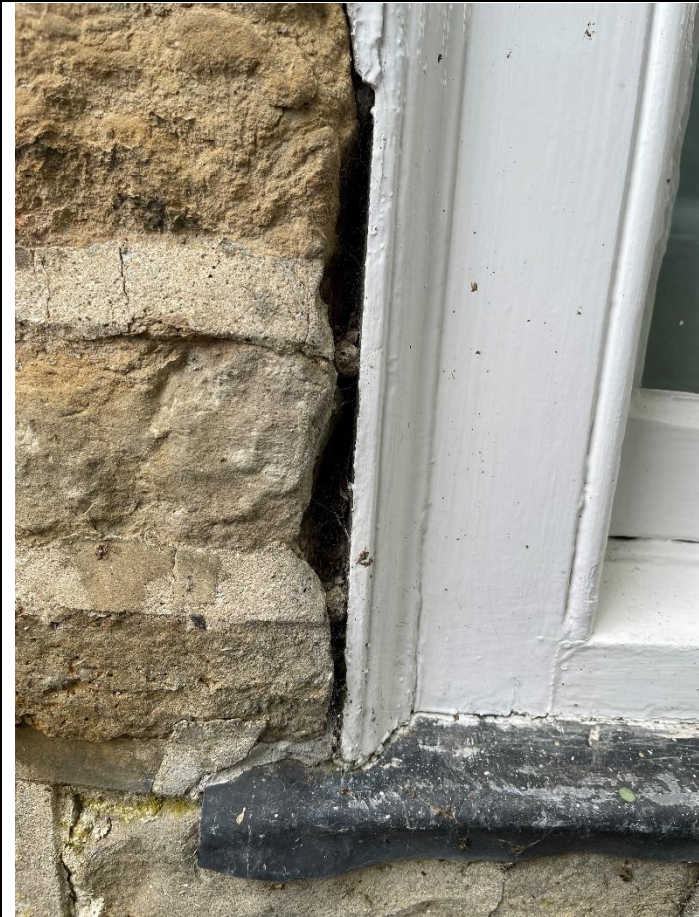
More water ingress around windows causing damp masonry and heat transfer as a result. Lead flashings underneath are pushing water into the cill.

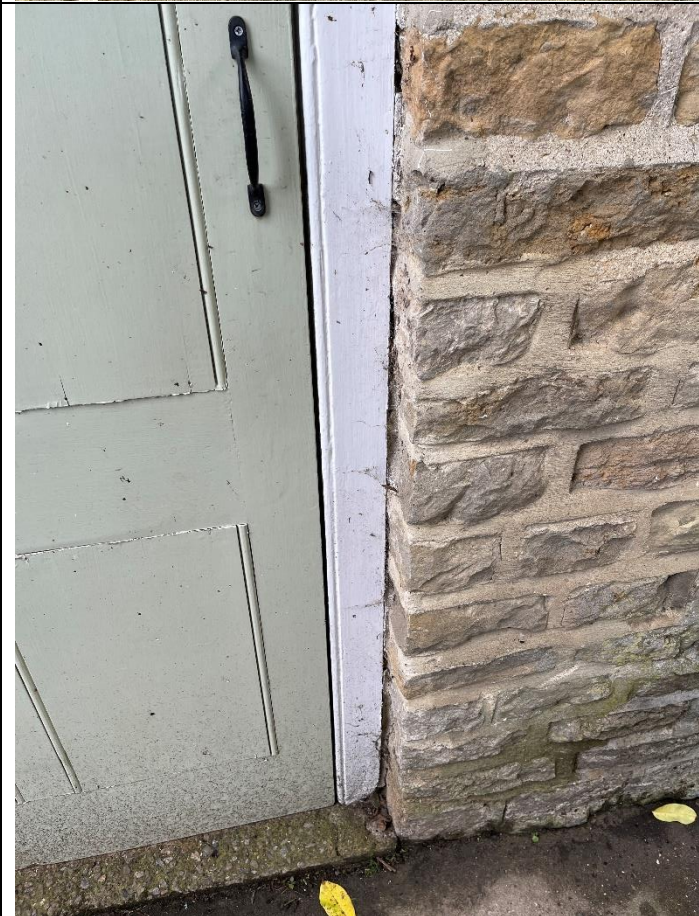
Gaps around door allowing water ingress and draughts.

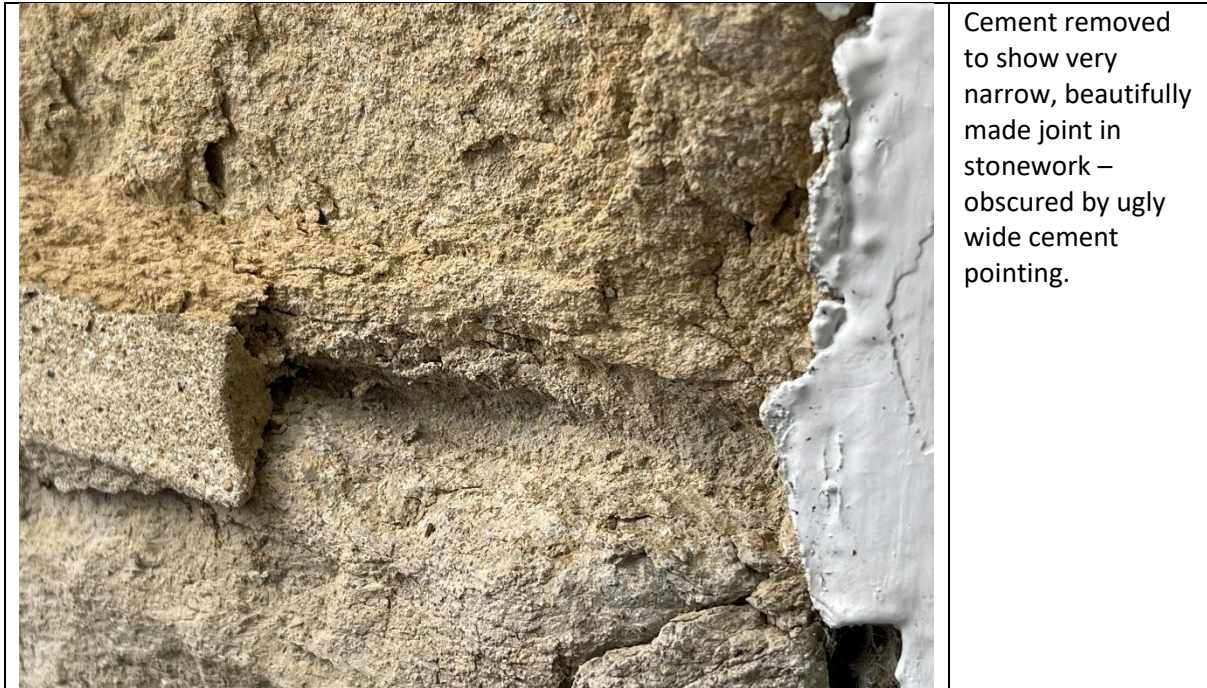
Cement removed to show very narrow, beautifully made joint in stonework – obscured by ugly wide cement pointing.

One would hope that at some point, the poor quality wide cement pointing could be replaced with hot lime mortar pointing to showcase historically and materially relevant techniques...

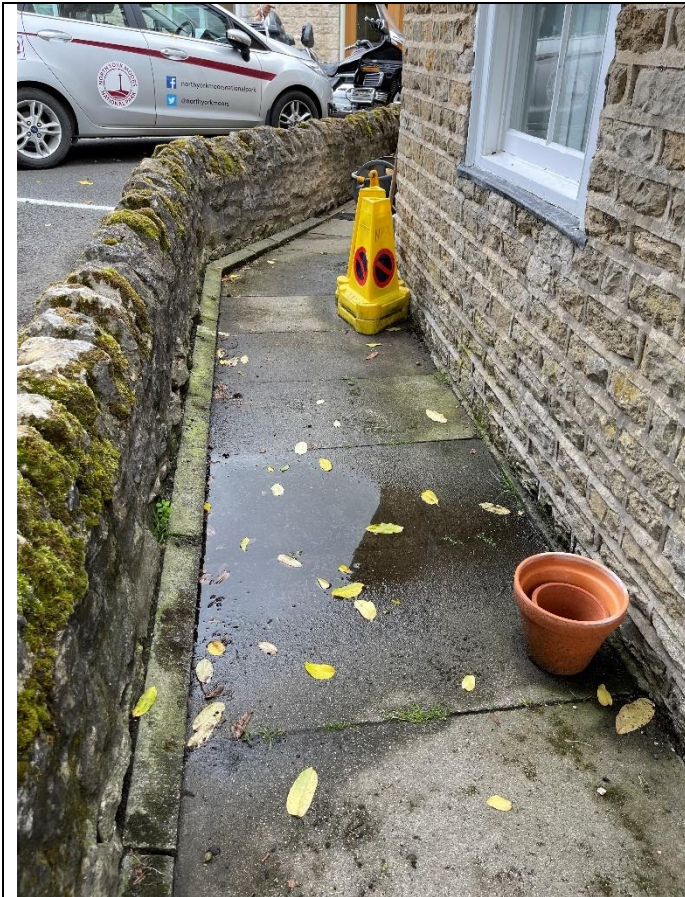
Paving at the rear, almost level – showing ponding. This has clearly not been laid with a view to free drainage, and is forming a well in which water collects and stresses the base of the wall. Paving is at the level of the internal floors and causing damp problems internally.

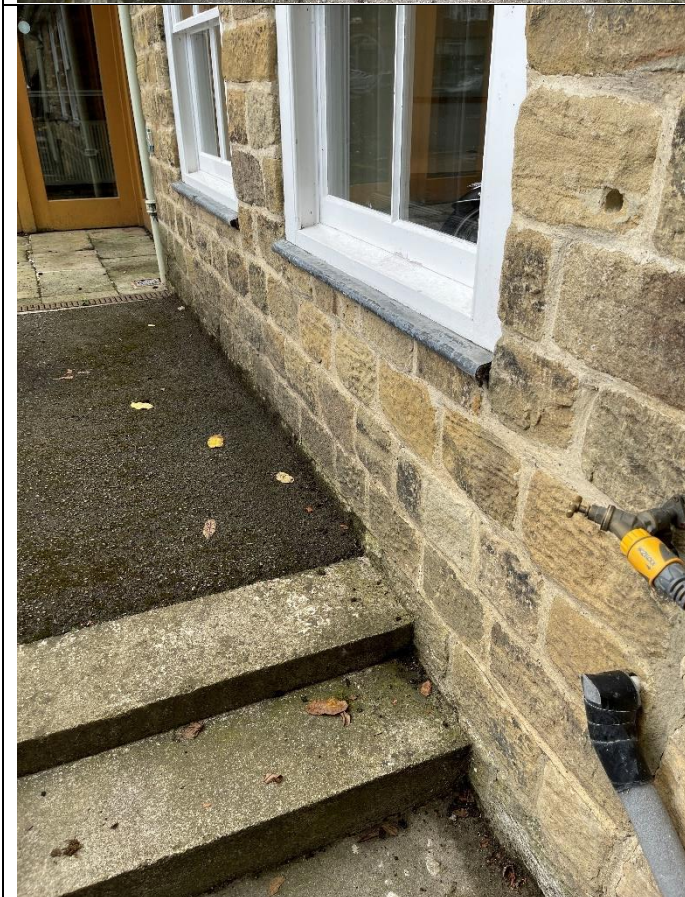
High ground levels which will ultimately cause damage to this wall internally. Note low level moisture in foreground between wall and paving

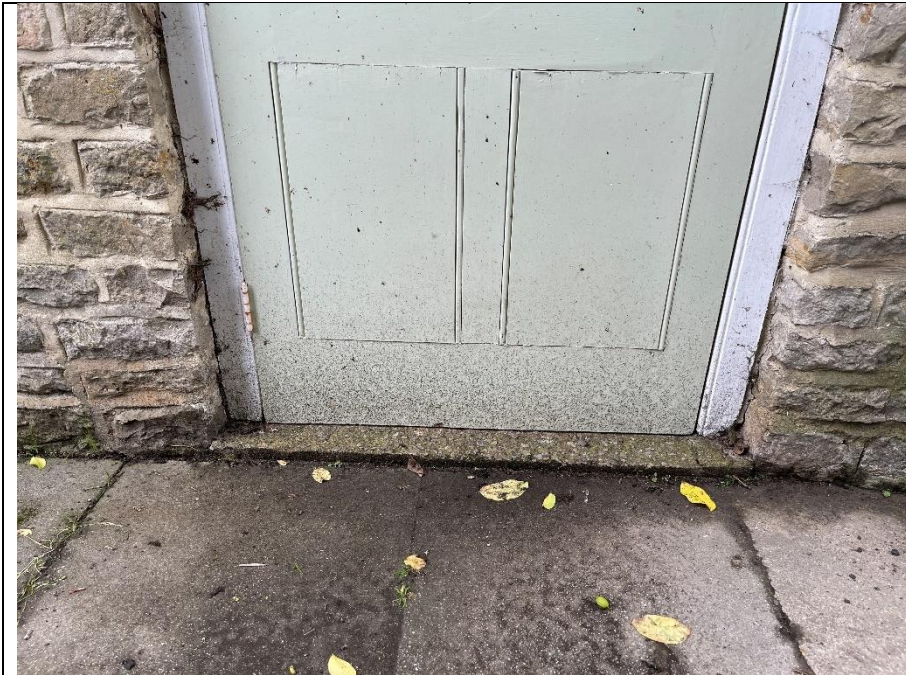
Rear door access to maintenance office. Water can just run under the door. Clearly the door is being badly splashed by water falling out of badly fitted guttering as well. The base of the frame is rotting, and stonework has been repointed in cement mortar presumably after the lime mortar leached out of joints.

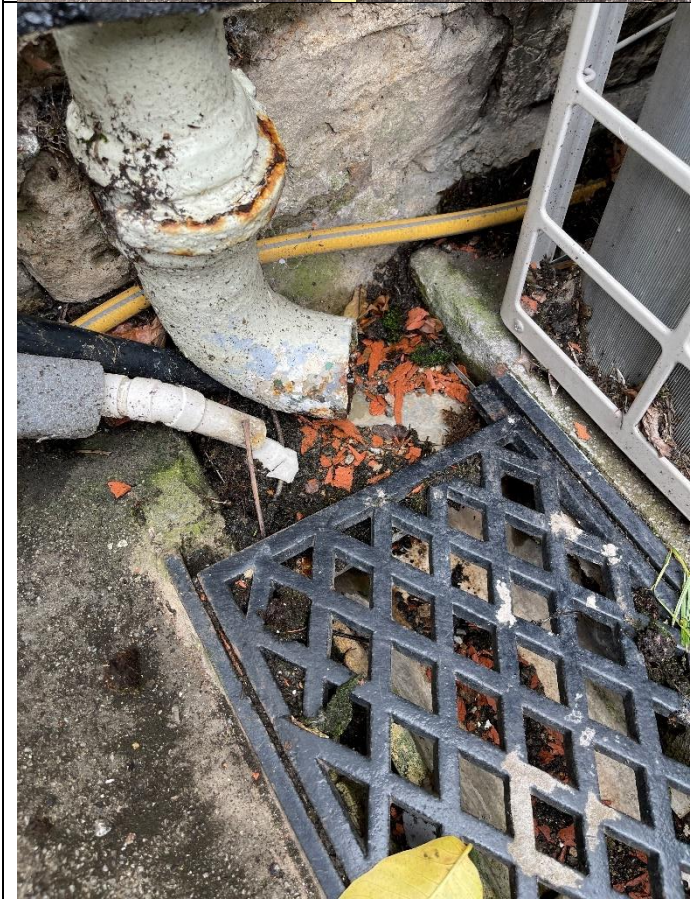
Blocked drain from rear roof area – clearly this has not been maintained for a long time. Note leaking downpipe, and accumulations of moss and algae, showing water retention against the base of walls. Downpipes should NEVER be allowed to discharge against the base of a wall like this.

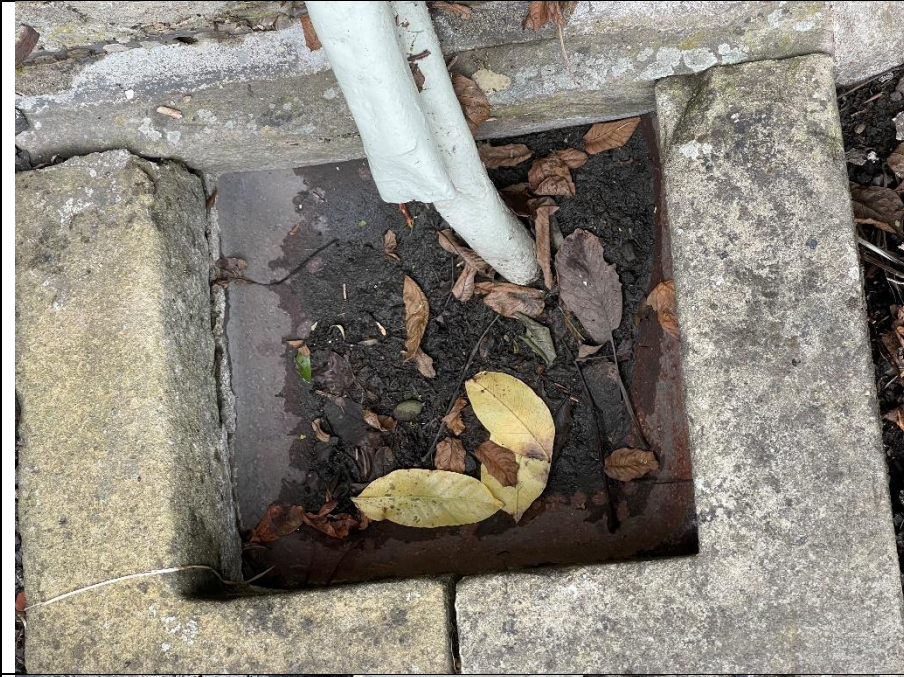
Blocked drainage gulley. Note the gulley itself is also cracked – allowing water to simply escape and soak the ground around the gulley, soaking the walls and foundations. This needs replacement as a matter of urgency.

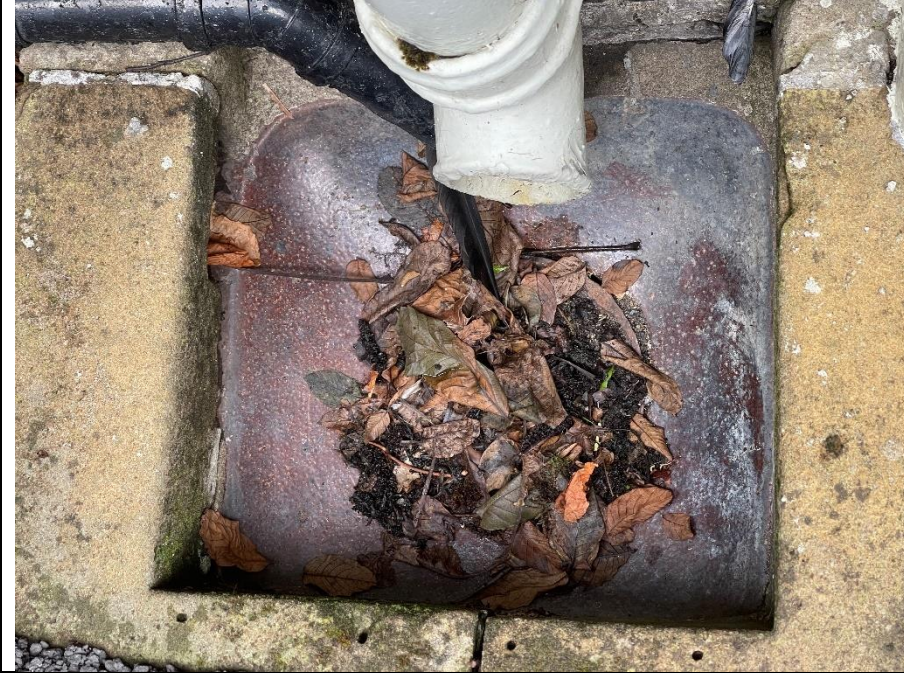
Another old, blocked gulley – water is splashing backwards, finding its way between gulley and wall, creating damp wall.

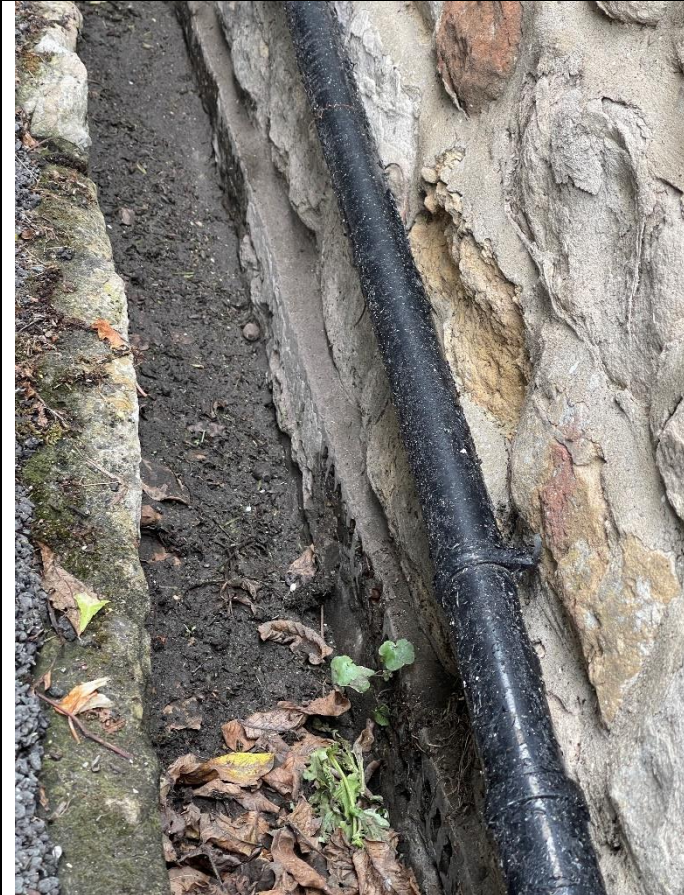
Similar situation near the main entrance – gulley blocked with rubbish, water building up and pouring through the bricks into the base of the wall and under floors. Note how the stonework here is spalling badly. This is because of extreme moisture stress created by damp walls and damp environment, together with cement pointing.

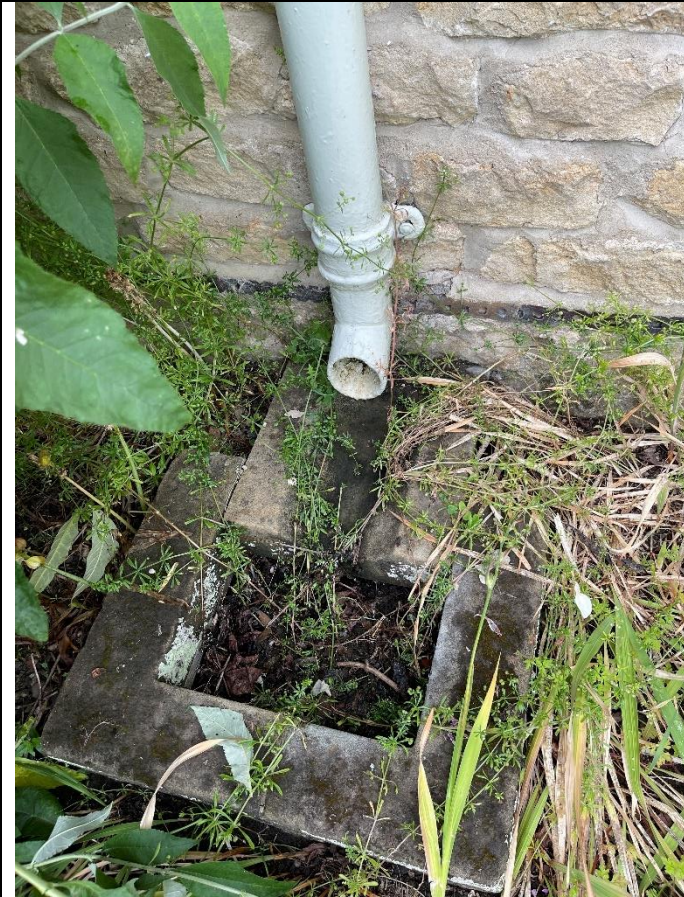
Blocked gulley at the front of the building. Choked with vegetation. Note perforated bricks, and cement pointing.

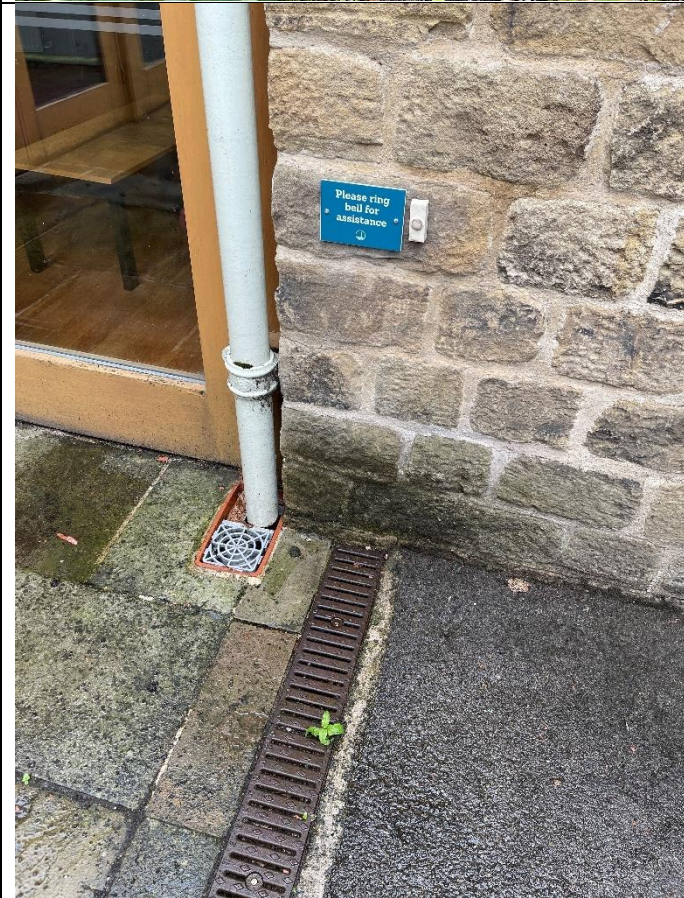
Drainage gulley by rear entrance showing water splash from broken gutter. Note also ground levels are way too high, and cement pointed stonework (This is modern extension – but should still comply with Building Regulations re: internal floor levels and drainage)

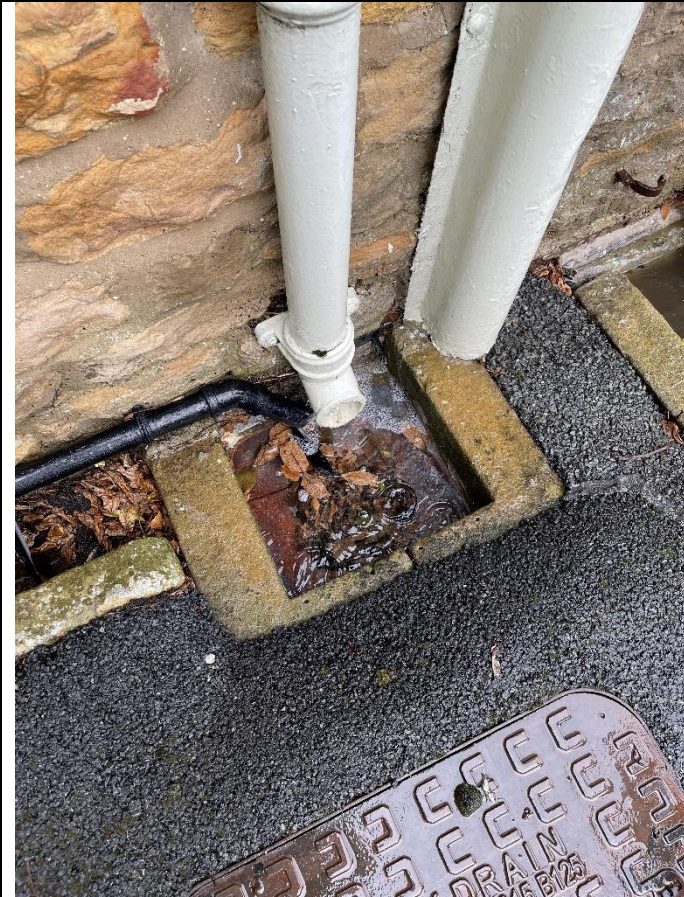
Another blocked gully and cement pointing.

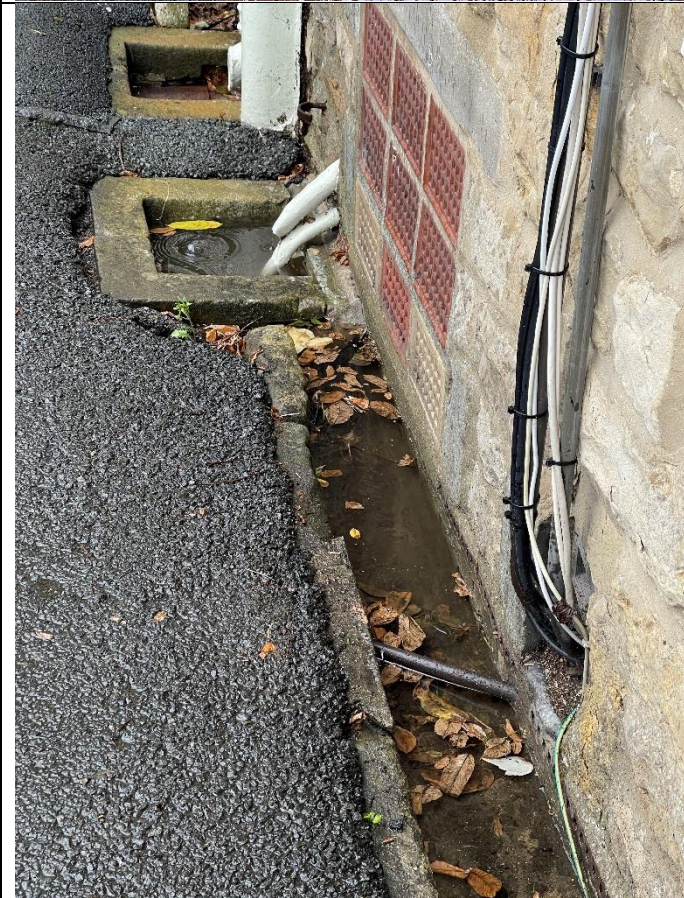
Entire side of building flooded, allowing water to pour into basement. Gullies and drains blocked, openings very poorly constructed (note ventilation bricks in what was presumably a cellar entrance at one point – these are not allowing for humidity controlled ventilation) Note cables entering and water able to draw into cable entry hole.

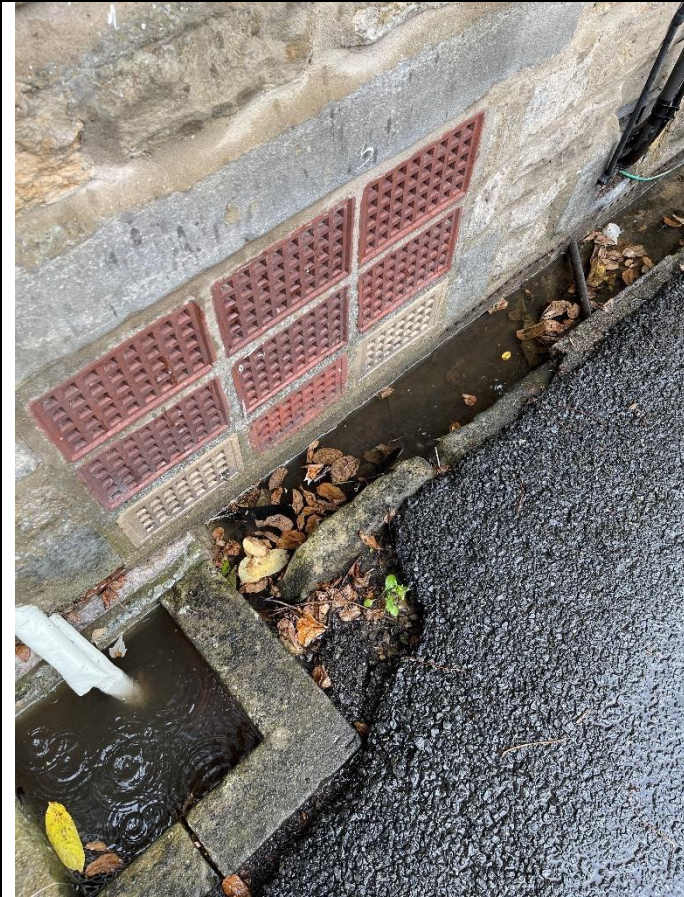
Note tarmac draining into gully, blocked, and water now pouring into the basement.

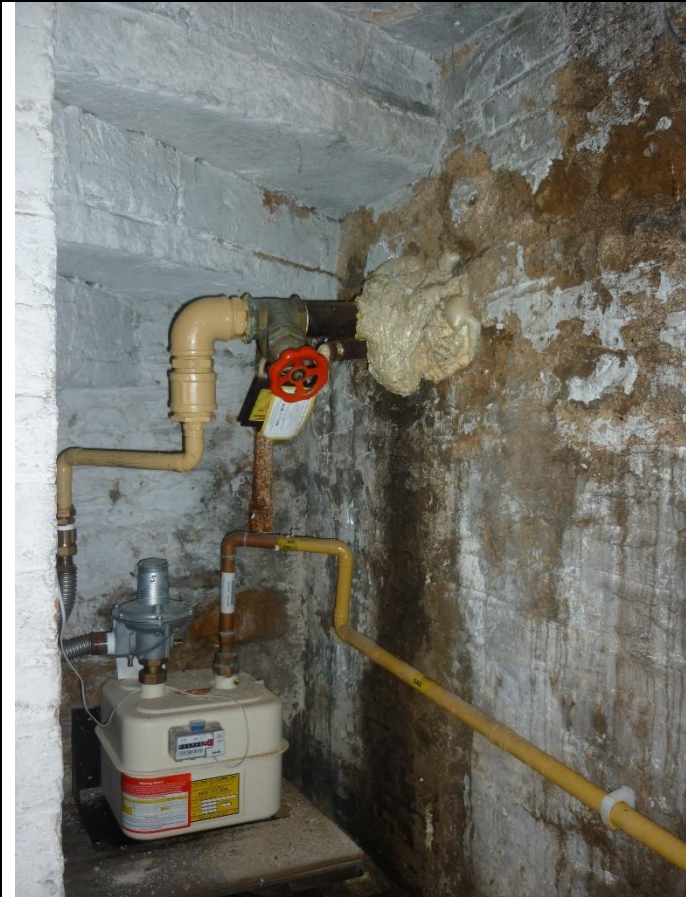
Basement showing water pouring into the area.

Entire basement was wet.

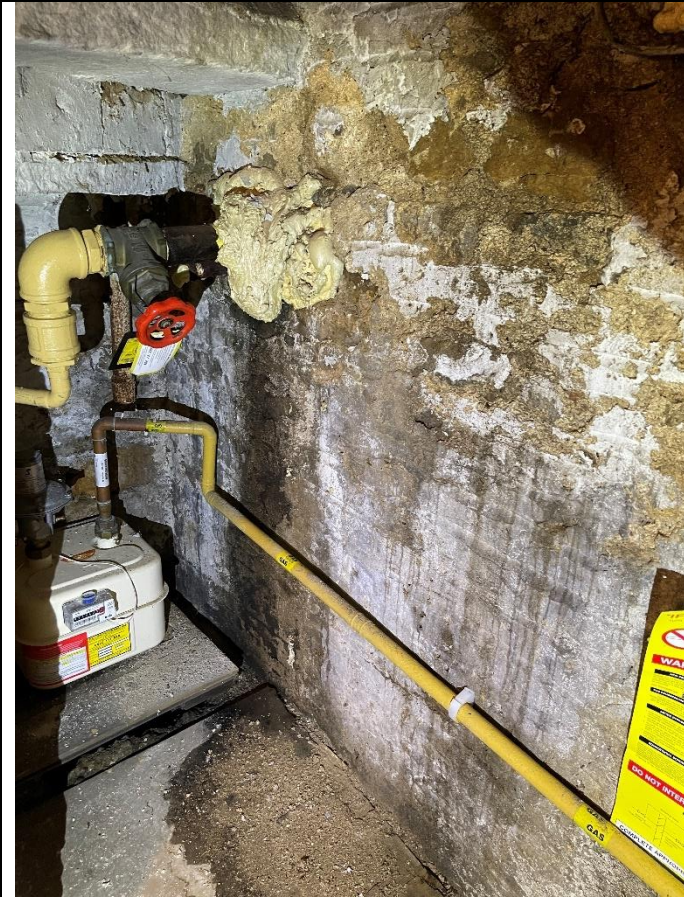
Soaked floor, water ingress everywhere. Note very poor approach to sealing round gas intake pipe with foam. This seals moisture into everything it touches – including the pipe. Ideally needs to be removed and replaced with lime mortar, in conjunction with sorting out drainage externally.

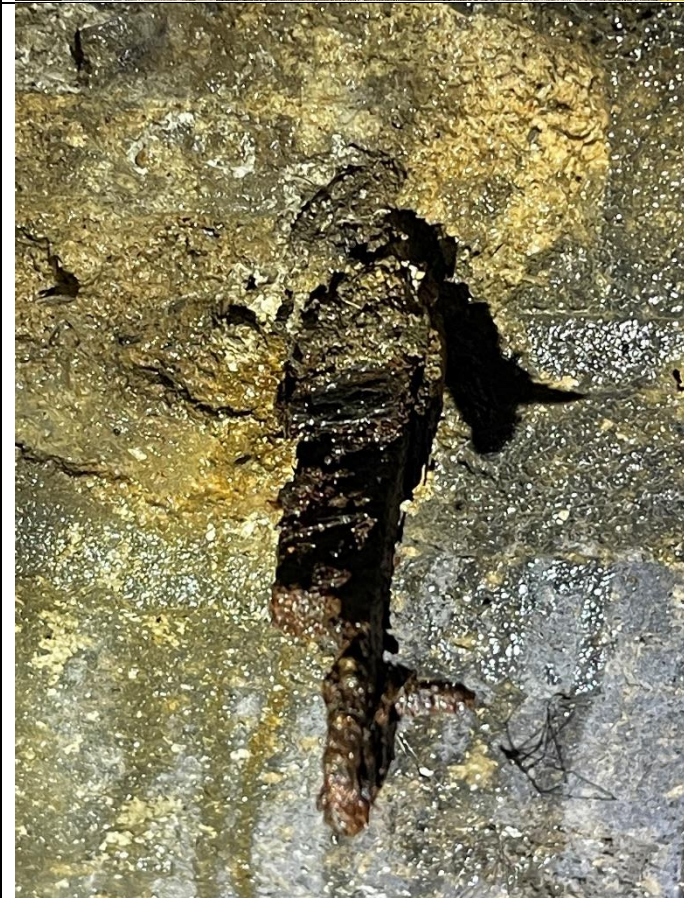
Rusting iron fixing in wall – this will cause jacking and structural damage of stonework if not removed. Iron expands greatly when it rusts.

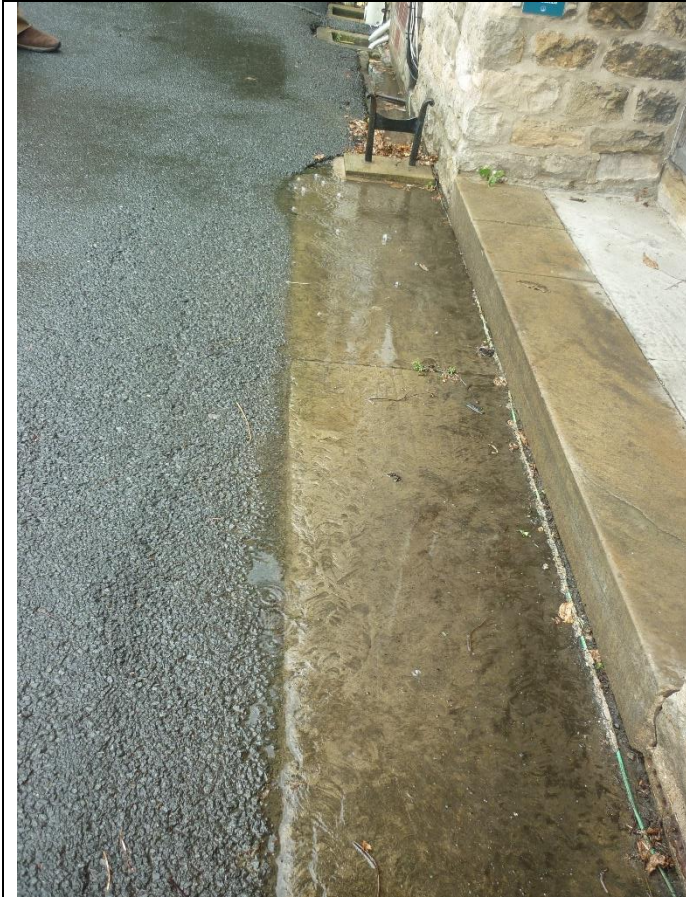
Tarmac draining towards building, ponding at front steps – very poor drainage.

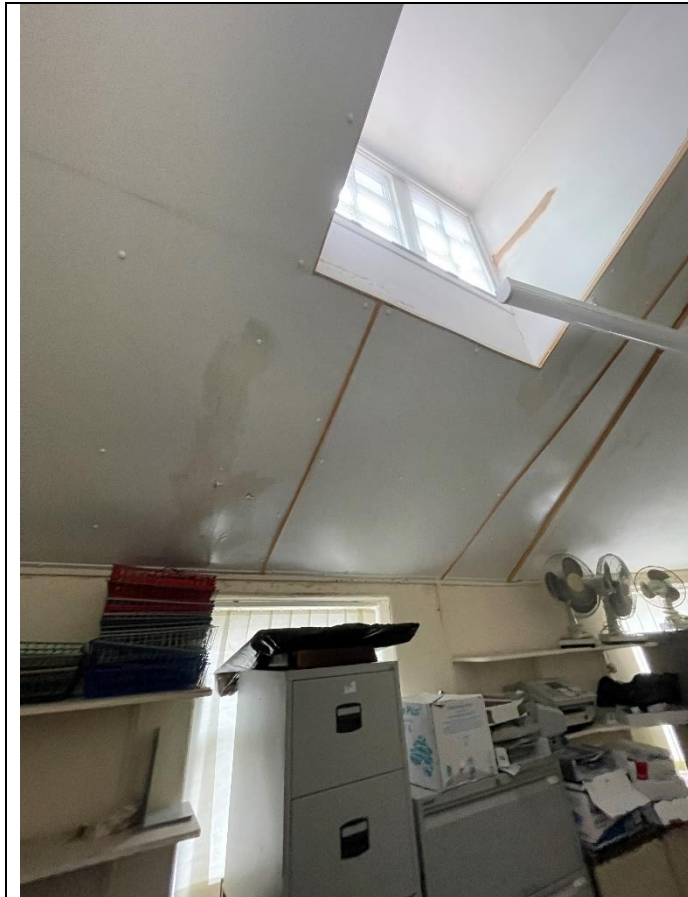
Physical roof leaks at the rear causing internal problems. There is no documentation as to how well insulated these ceilings are – it would be sensible to undertake some minor opening up works to see how this has been done, and whether it is trapping any moisture.

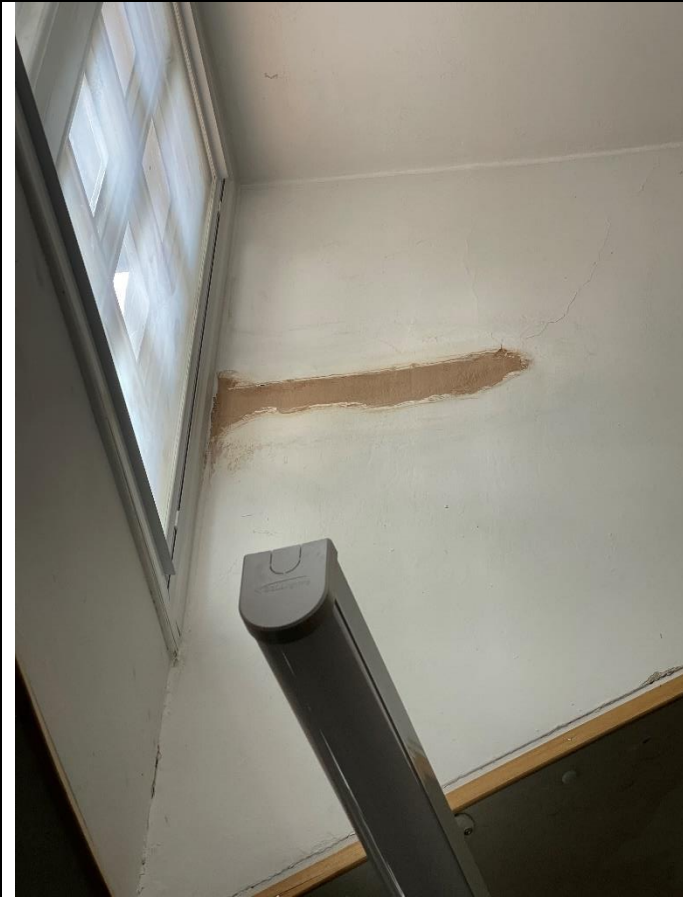
Ditto – the leadwork to the cheeks of the dormer is scrap. Thermal imaging showed very little insulation to any of the dormers, so these need to be documented as a priority area to reduce heat loss.

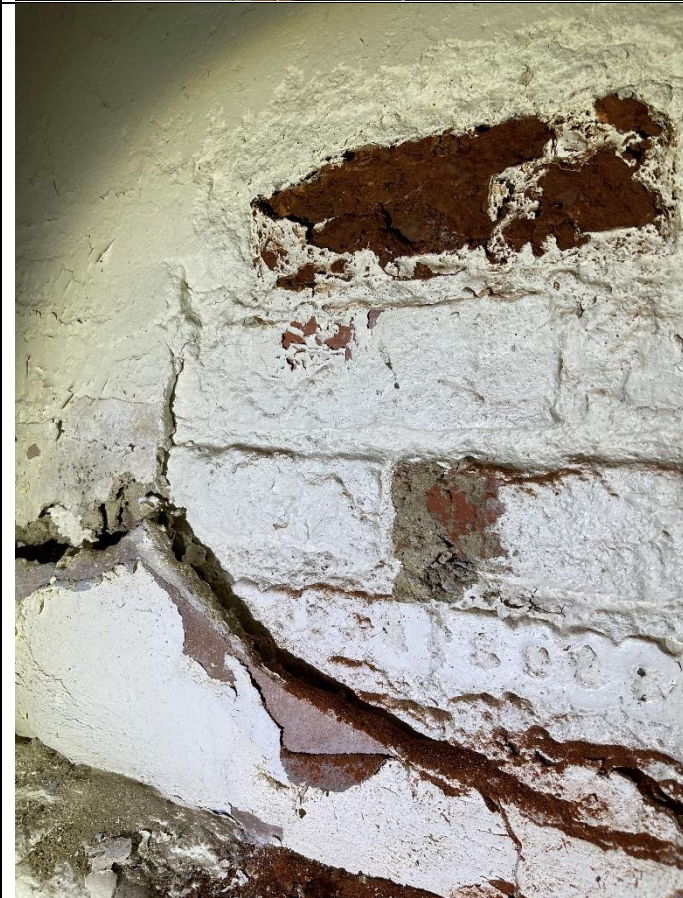
Disintegrating stone in the basement due to plastic paint trapping high levels of humidity. Note cement render falling off the wall at bottom. The basement area is a priority for drying out the fabric and reducing moisture levels.

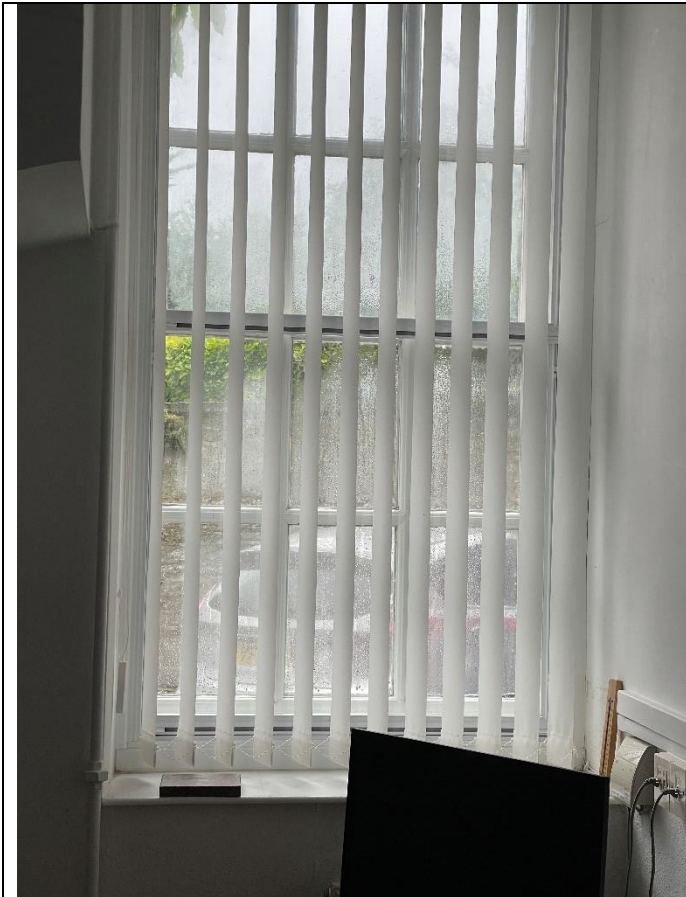
Office window almost running water from the basement rooms below – this is diffusing up through the floor and doorway, saturating the air above.

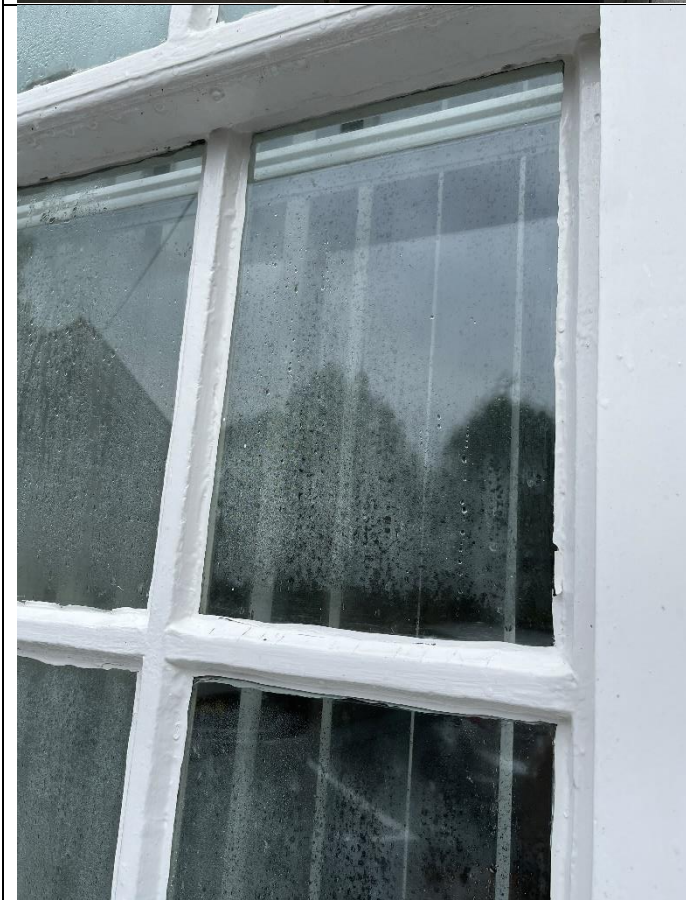
Condensation appeared on this window within minutes of water starting to flow in the basement from blocked drains. This shows how reactive a building like this is to applied moisture.

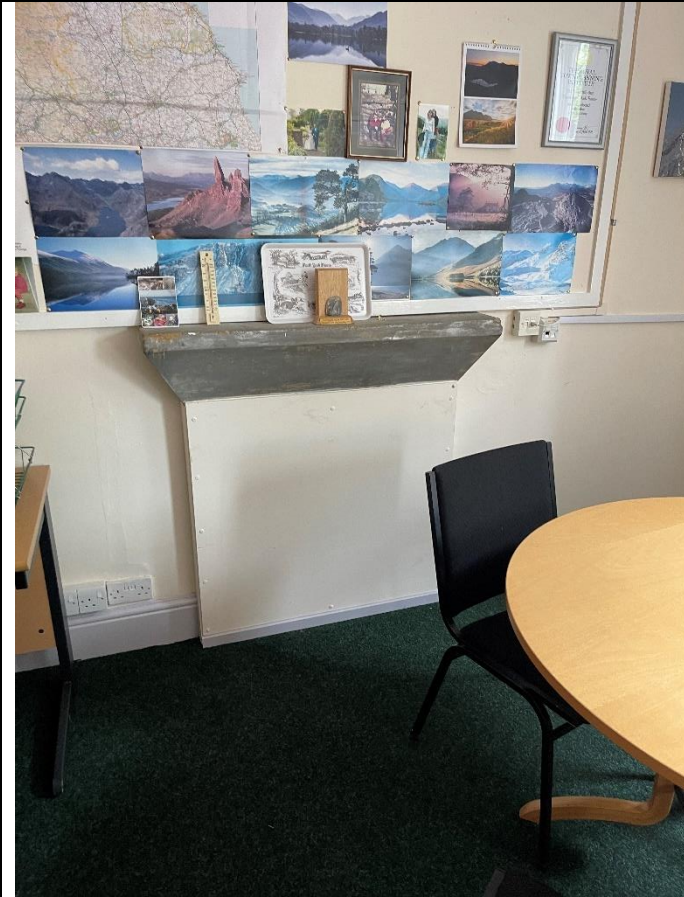
Blocked fireplace. At present there is no information as to the state of these flues – they all almost certainly need sweeping clean to remove salts and soot deposits which will hold moisture, and increase rates of heat loss resultingly.

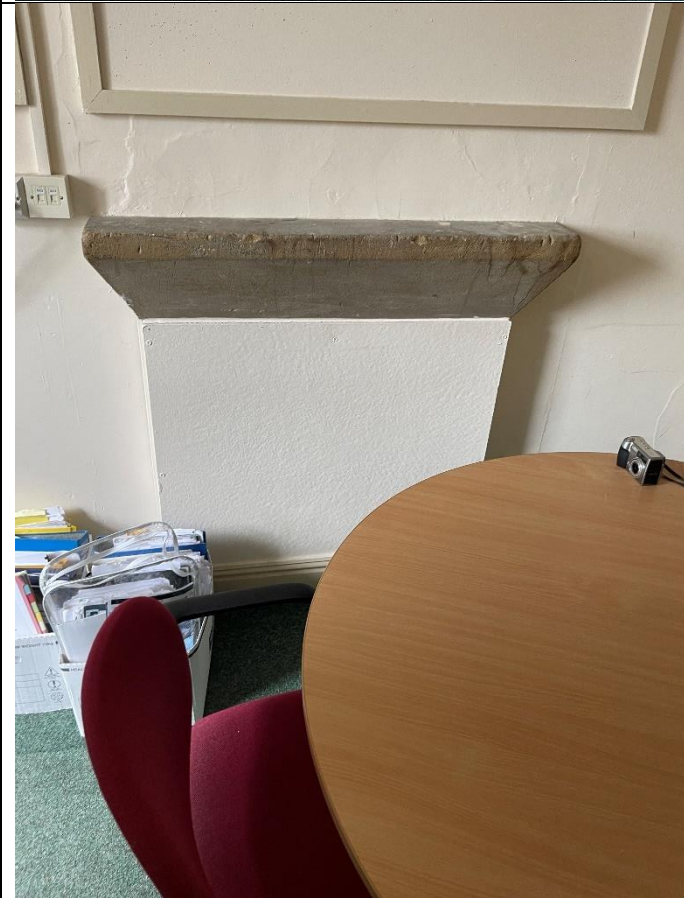
Blocked fireplace again..

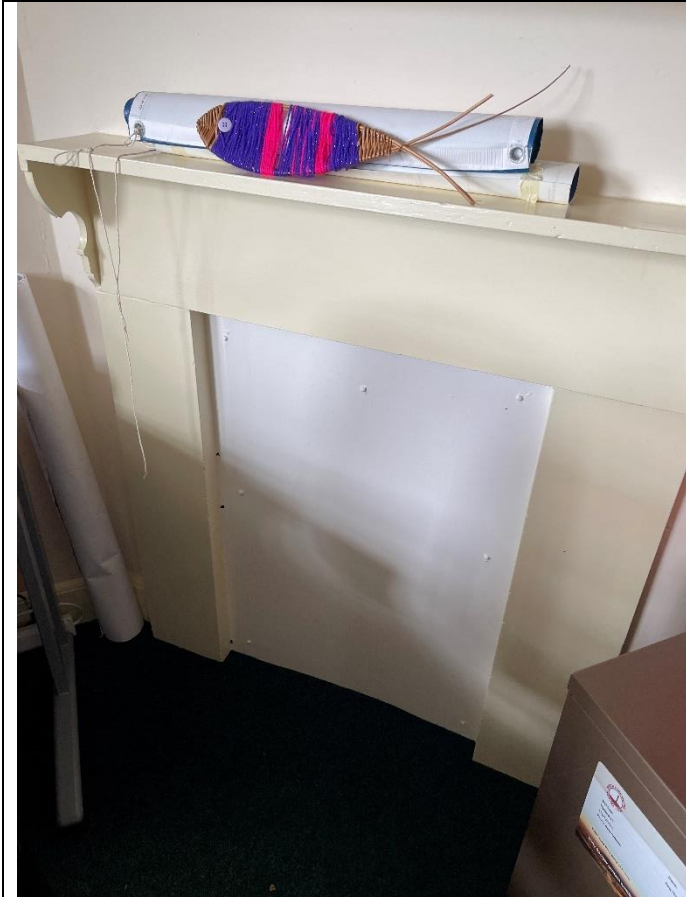
... and another. All opportunities to improve air quality and potentially address minor moisture issues from salt related moisture absorption.

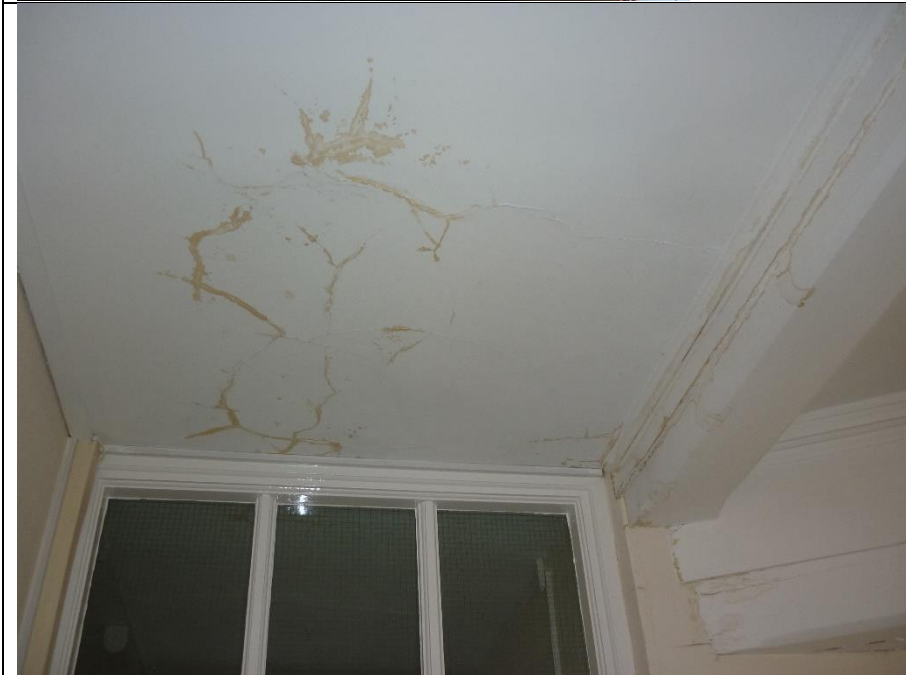
Historic roof leakage damage – I could find no evidence of any current moisture

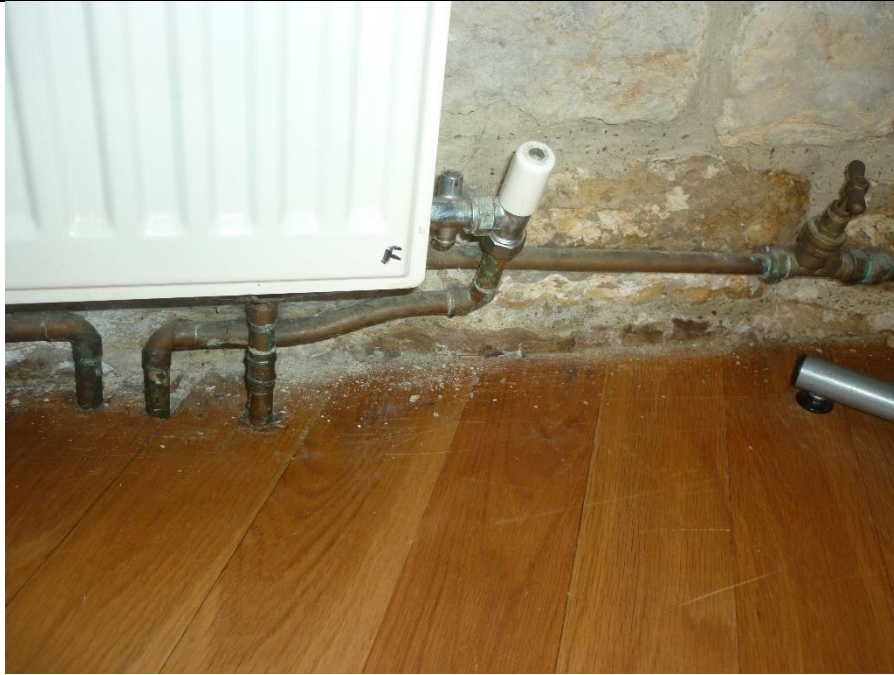
Moisture being driven sideways from under the concrete slab to the rear entry hall. This is the join between modern, impermeable building 'technology' and traditional, breathable wall – moisture from under the modern slab is trying to escape and is blowing the stonework and leaving salts behind. It is struggling to escape because the wall is pointed with cement.

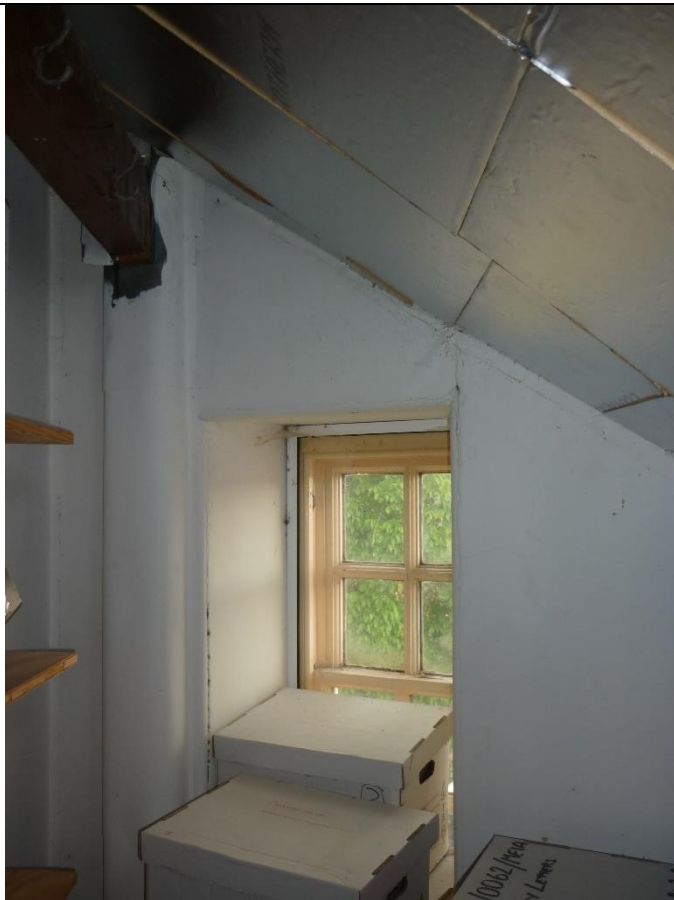
PU foam board on ceilings. Traps condensation between underside of roof and boards, often resulting in damp problems at the join with the wall. Leaky joins, which means poor quality insulation and draughts bleeding heat away. Note mould in corners of window reveals, indicating historically high moisture levels in the air – humidity control of the atmosphere in the building will reduce this, prevent interstitial condensation, and consequent heat loss.

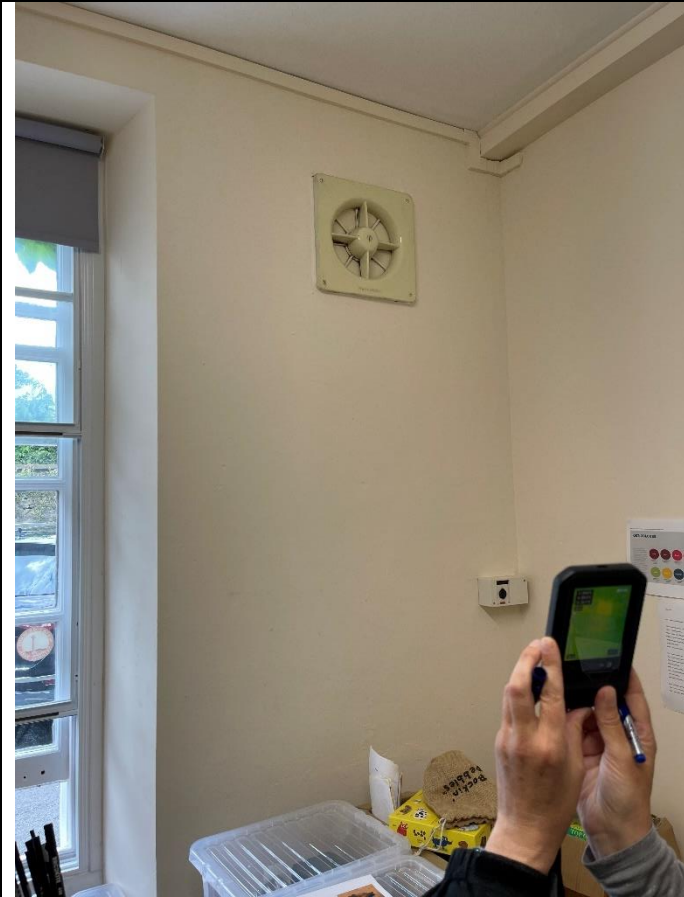
The only ventilation I could find – not working! Such outmoded technology needs to be removed and replaced with modern humidity controlled equipment. Existing openings may well be usable to prevent any further impact on the Listed fabric.

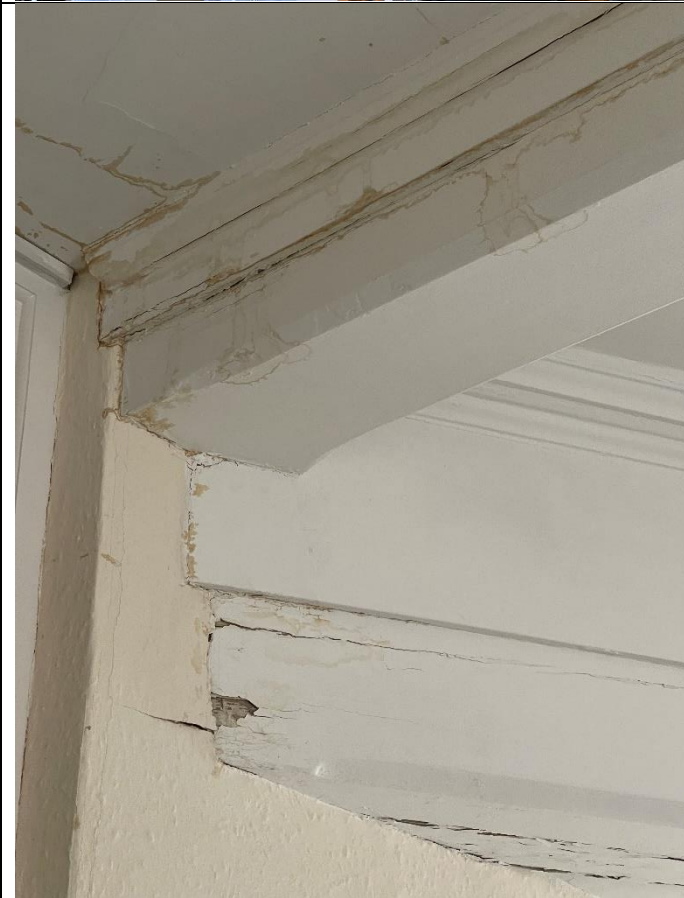
Historical leak – timber was tested and found to be dry – so should not be deteriorating in any way.

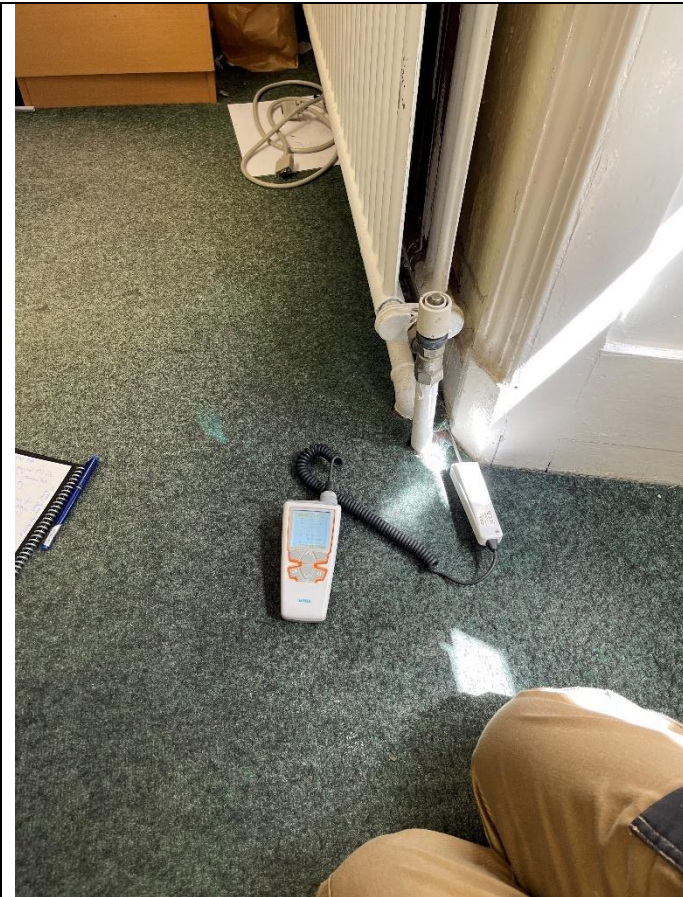
Front elevation near blocked drain – moisture levels were a little high – floors appear to be sending moisture sideways (water finds it hard to escape through plastic carpet / underlay... so goes sideways into the walls. Ideally more investigation of these floors is needed to establish how dry the spaces below them actually are.

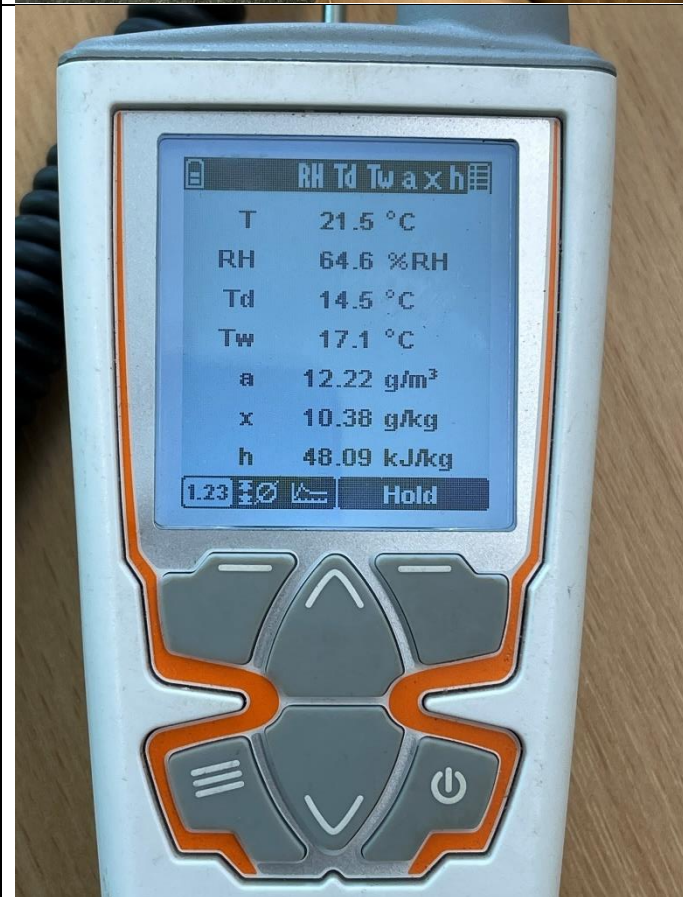
High moisture level relatively speaking – Absolute of 12.22 grams as opposed to ideal of 7 g/m³. This begs the question that sub floor spaces need better ventilation and investigation of any possible moisture sources – probably drainage related. Floor coverings are non – permeable so are trapping moisture into any voids below them.
