Building Survey

The Old Vicarage

Report produced by Peter Ward, BSc

July 2021

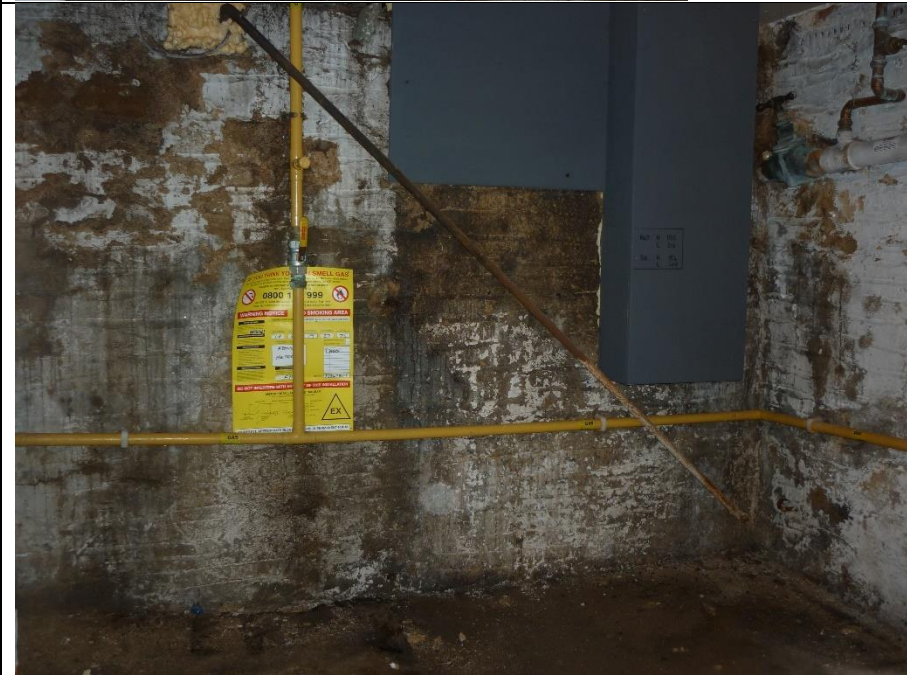
Basement showing water pouring into the area.
