Building Survey

The Old Vicarage

Report produced by Peter Ward, BSc

July 2021

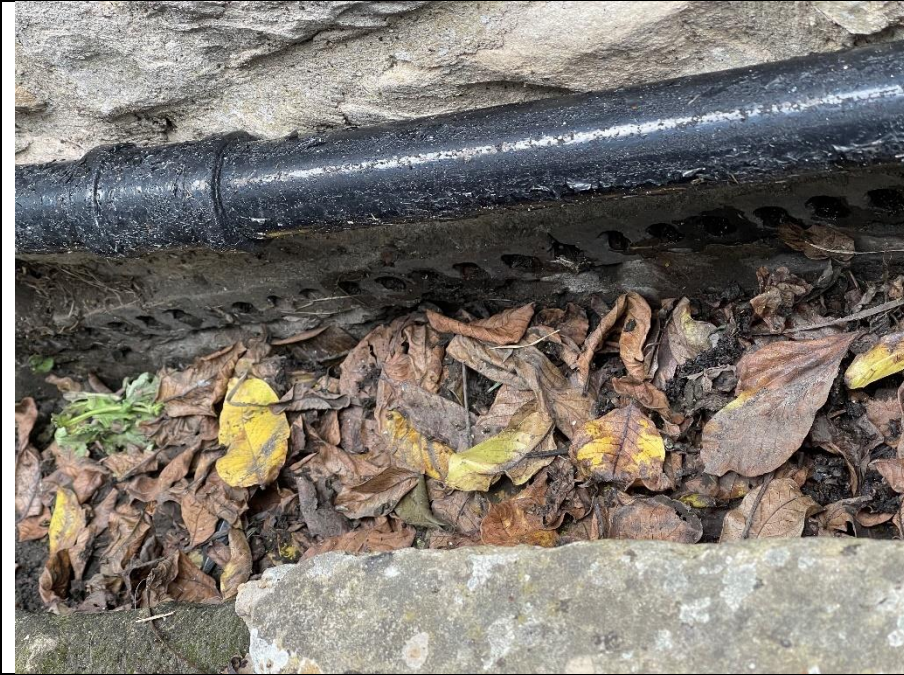
Another old, blocked gulley – water is splashing backwards, finding its way between gulley and wall, creating damp wall.

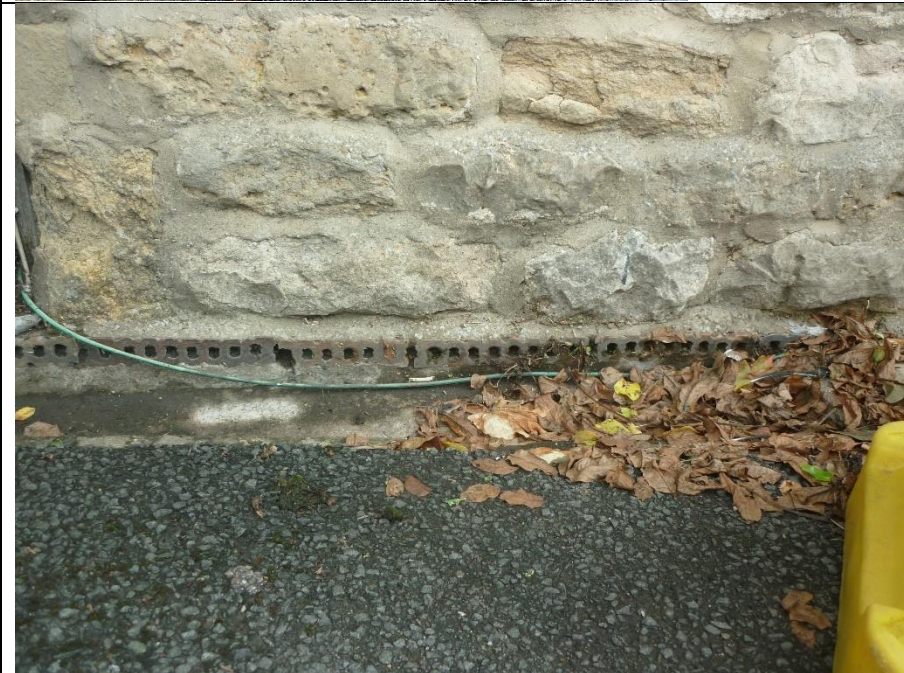
Note tarmac draining into gully, blocked, and water now pouring into the basement.
